BLOCK 407 MASTER PLAN

PROJECT NAME: BLOCK 407 MASTER PLAN
GSBS PROJECT NUMBER: 2-27-2022-04
DATE: September 9, 2022

COMMUNITY DEVELOPMENT
SALTLAKE COUNTY
PUBLIC SERVICES

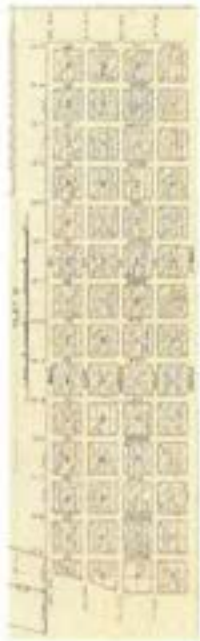
Figure 2.4. The original 56 blocks of Plat D. Credit: Nicholas G. Morgan, Sr.

The layout of Plat D marked somewhat of a departure from the typical plat that had been used in laying out the previous three plats (A-C). Whereas the individual blocks in Plats A-C were 40 rods (660 feet) square, making them 10 acres, those of Plat D were 20 rods (330 feet) square, making them five acres. Additionally, each block was divided into four parcels or lots instead of eight as were the blocks in Plats A-C. Lastly, streets within Plat D were five rods (80 feet) wide with 10-foot-wide sidewalks where those in the preceding plats had been five rods wide with 20-foot sidewalks. The atypical configuration of Plat D was likely an adaptation to the relatively steep terrain and lack of easily available freshwater in the area. The lack of water in particular would have made

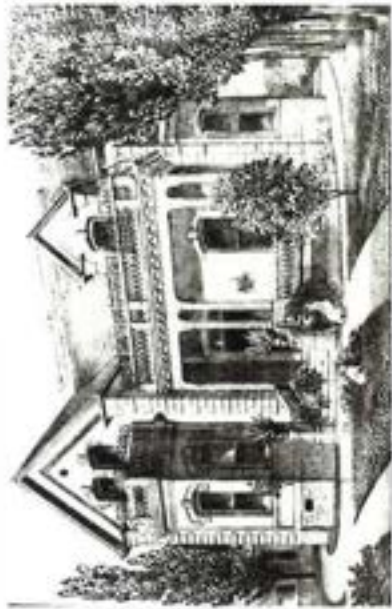
Figure 2-7. 1887 drawing of the Gladwin House. Credit: Utah State Historical Society

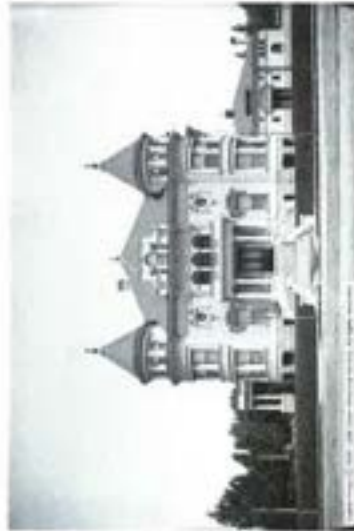
Figure 2-11. 1907 image of the Kearns Mansion and carriage house.
Credit: Utah State Historical Society

The carriage house was built concurrently with the mansion (see Figure 2-11). The building is 1/2 stories in height with an exterior also of oolite limestone and similar Chateausque architectural details. The horse's head sculpture over the front bay doors provides a clear signal of the building's original use. The first floor was designed for elaborate horse stalls and area to hitch and unhitch buggies and a tack room. The stalls were constructed of two-inch planking, tongue and groove, and fine iron and brass grillwork around the top of the stalls. The second floor was split between three areas: grain and hay storage above the stalls, buggy storage, and a caretaker's apartment and bathroom. A hand-operated elevator in the southwest corner hoisted buggies up and down for storage and use. (Arrington & Swinton 1987, 14-15)

Figure 2-11. 1907 image of the Kearns Mansion and carriage house.
Credit: Utah State Historical Society.

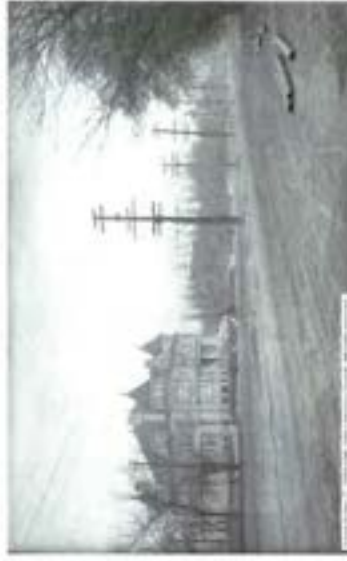
Figure 2-14. 1905 image of South Temple near the Kears Mansion. Note yard terracing at Kears Mansion and narrow park strip. Credit: Utah State Historical Society.

Broader changes on and around Block 407 took place during the Keams Family Period that influence the overall setting of the block today. For example, South Temple was an unpaved road with a center-running streetcar line with an electrical catenary at the time the Keams Mansion was constructed. The road was a two-level feature with the elevation of the north half as much as two feet higher than that of the south half in some areas (see Figure 2-14). In 1902, the city began paving streets in the downtown area. In 1905, they turned their attention to South Temple. Over the next two years, South Temple was paved in a combination of cobblestones and bricks; sections of mist cobblestone paving were found below modern-day asphalt when the road was reconstructed in 2002. The two-level nature of the road was maintained. Several years later, during the early 1910s, the northern half of the road was lowered to its approximate current elevation to match the grade of the southern half, and the streetcar tracks and catenary poles were removed. Lowering the north half of the road required widening the park strip mitigate the slope between the sidewalk and the curb. This change is evident in a 1912 photograph of the sidewalk area in front of the Keams Mansion (see Figure 2-15). The park strip trees that were already present there were left in place, though widening the park strip to the south created a situation wherein the trees, which were originally planted in the very narrow park strip present prior to 1910, are offset closer to the adjacent sidewalk instead of near the center of line of the park strip (see again Figure 2-15). Onion-topped steel lattice utility poles and light fixtures were also installed along the north side of South Temple at that time.

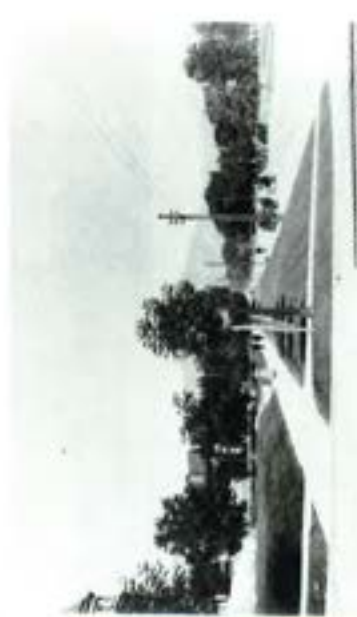
Figure 2-15. 1912 image of South Temple and park strip in front of the Keams Mansion
Credit: Utah State Historical Society

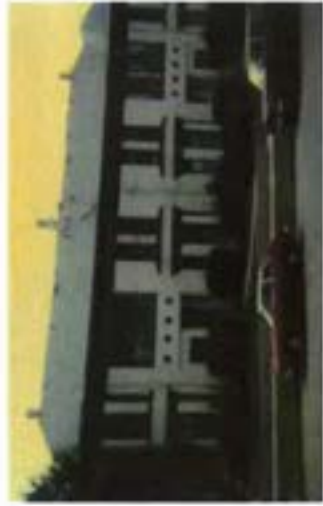
Figure 2-17. Keams Terrace No. 2 as it appeared in 1963. Credit: Utah State Historical Society.

While it is unknown when Thomas Keams or the Keams family sold Keams Terrace No. 2, the building continued to be four units through 1942 (R.L. Polk & Co. 1942). However, by 1950 the building was subdivided and remodeled into 14 apartments, the same configuration which it possesses today (see Figure 2-17).⁴ (Sanborn Fire Insurance Co. 1950, 1958, 1963, 1969) By 1958, a wall separated the apartments from the Keams Mansion property.

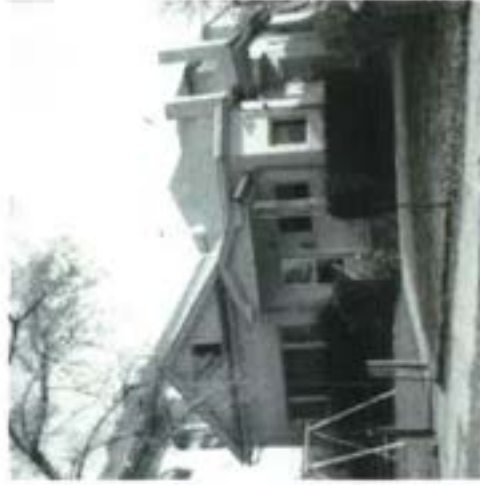
Figure 2-18. 34 G Street as it appeared in 1966. Credit: Utah State Historical Society.

The house at 34 G Street continued to be listed as a single-family residence through at least 1942 but was formally converted to three apartments prior to 1950. (R.L. Polk & Co. 1942; Sanborn Fire Insurance Co. 1950, 1958, 1963, 1969) Today, the building remains as three units and was last remodeled in 1995 (see Figure 2-18). (Salt Lake County 2022)

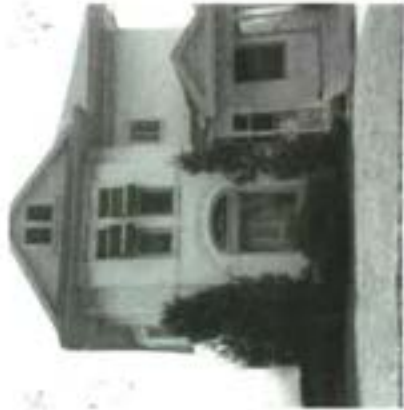
Figure 2-19. 38 G Street as it appeared in 1966. Credit: Utah State Historical Society.

By 1950, the house at 38 G St. was listed as five apartments and it remained in the configuration through at least 1968 (see Figure 2-19). (Sanborn Fire Insurance Co. 1950, 1958, 1963)

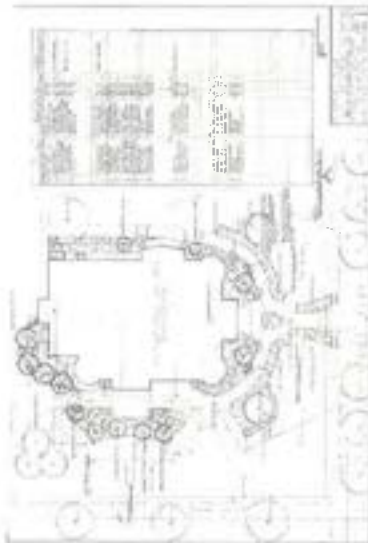
Figure 2-20. The Korsten Hansen design for the Utah State Historical Society, 1965.
Credit: Utah Division of Facilities and Construction Management.

A planing plan was drawn up by renowned Utah landscape architect Karsten Hansen in 1965 for the Utah State Historical Society (see Figure 2-20). The plan did not propose changing any of the landscape vegetation beyond the sidewalks or within the Great Lawn, and did not add any new landscape. What the landscape development plan called for was a greater density of plantings immediately adjacent to the Kearns Mansion, the addition or expansion of the planting area on the east side of the property adjacent to the Glendinning fence. However, it appears from historic photographs and aerials that very little or none of this plan was carried out. (Aerial Photographs 2022)

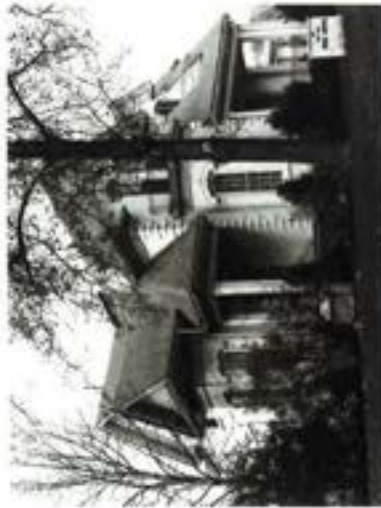
Figure 2-21. The Salt Lake Dental Hospital following many of the alterations, circa 1966.
Credit: Utah State Historical Society

Dr. Burton's adaptations physically altered the building and property for his business (see Figure 2-21). The transition of converting the entire Glendinning property to commercial use was in earnest by 1962 when the carriage house was demolished for a parking lot. (Aerial Photographs 2022) Sanborn labeled the house as a store (for commercial use) and dwelling, while the carriage house was labeled as a dwelling on the west and auto and store on the east. (Sanborn Fire Insurance Co. 1963)

By 1966, a one-story east addition and a two-story north addition were constructed as the dental hospital wing and patient rooms respectively. To better accommodate clients, the primary entrance was moved from the central doorway to the southwest doorway and porch (Utah State Historic Preservation Office 1/2021). Vegetation at this time appears to have been predominantly lawn, with foundation plantings including some type evergreen shrubs around the front and a mature tree.

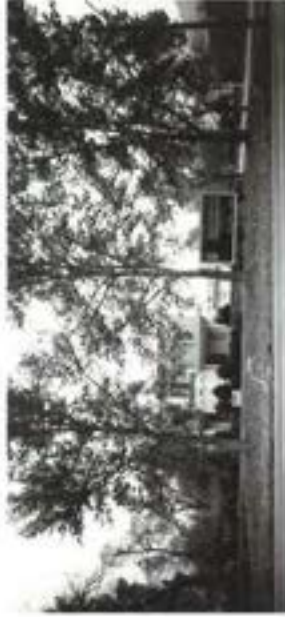
Figure 2-22. Glendinning House boarded up and marketed for redevelopment, 1975.
Credit: Marriott Library, University of Utah

By 1975, the Glendinning house was boarded up and the property marketed as a high-rise condominium site called "The Mansion House," a six-story concrete structure by developer Meeks Withlin (see Figure 2-22). The sign also stated that it was a "downtown prime location for condominiums" (Cooley 1993). Utah Arts Council Director Ruth Draper mobilized to have the Utah State Legislature step forward to purchase the house with the intent to make it the new office and gallery for the agency. (Utah Division of Arts & Museums 2018). Fortunately the legislature recognized the potential problems having a large commercial development next to the Kearns

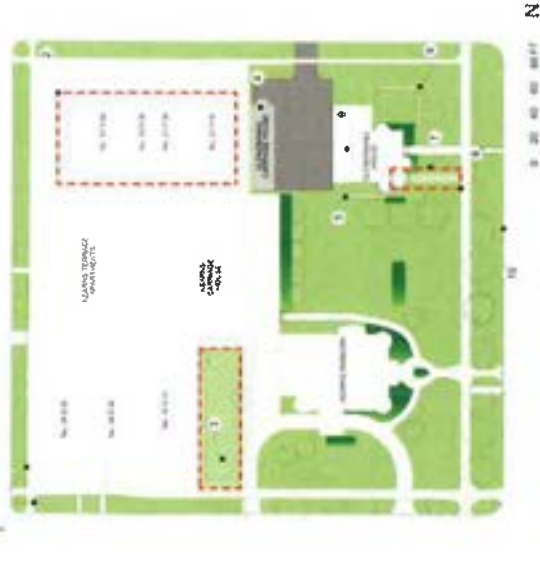
Figure 2-23. Period Plan - Commercialization Period, 1935-1973

- COMMERCIALIZATION PERIOD (1935-1973)**
- 1 Lawn
 - 2 Walkways
 - 3 Paved Area
 - 4 Asphalt
 - 5 Landscape Objects
- Notes:**
1. The primary entrance moved from the central doorway to the southwest doorway and porch by 1962.
 2. Old asphalt signs.
 3. Back wall.
 4. Building additions.
 5. Converted to regular pole street light.
 6. The primary entrance moved from the central doorway to the southwest doorway and porch by 1962.
 7. Old asphalt signs.
 8. Back wall.
 9. Building additions.
 10. Converted to regular pole street light.

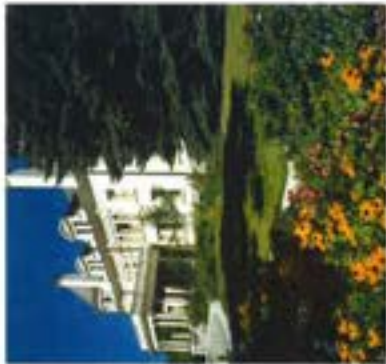
Figure 2-25. View northeast in 1980s era post renovation with driveway, location change. Credit: Arrington & Swinton

The restoration's primary focus was on critically needed updates to the interior. However, one significant change requested by Governor Matheson was to make the Mansion ADA accessible by adding a wheelchair lift and porch to the porte cochere. Pouch steps on the new structure were designed to have a gradual rise. (Parkinson 1978) The Governor was a proponent for accessibility and received an award in March of 1982 for his many efforts. (Shields 1982) The addition of the wheelchair lift necessitated moving the circulation path of the driveway so it passed in front of the new porch instead of underneath (see Figure 2-24). Moving the driveway created a wider planting bed and new turf area on the southwest side of the Mansion while reducing the turf area to the west (see Figure 2-25).

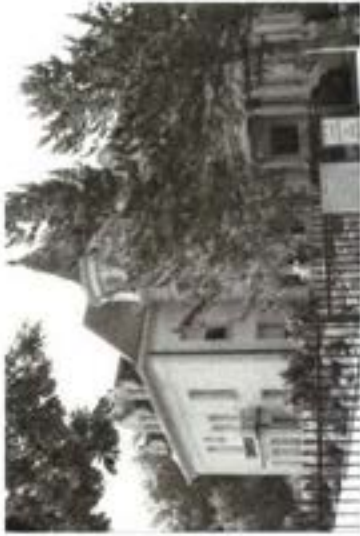
Figure 2-27. Landscaping and fencing circa 1980. Credit: Utah State Historical Society.

Another change which appears to have occurred during this period is the addition of plantings in the northwest beds adjacent to the Mansion (see Figures 2-26 and 2-27). Finally, the block was altered when the grassy area north of the Gledinning property was paved in asphalt to provide more parking for the Mansion and the Utah Fine Arts Division. (Historical Aerials 1977 & 1980)

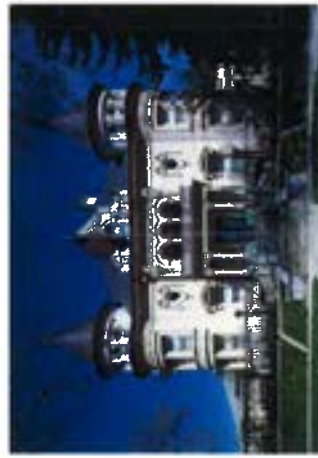
Figure 2-29. View of main facade after first security fence was installed. Credit: Library of Congress

1982) Completed in August of 1982, the security fence had four gates; three were manual and one was an electric gate for vehicular access to the main parking lot on the northwest side of the property.⁹ (Jensen 1982) For the first time in history the Governor's Mansion was secured from the public.

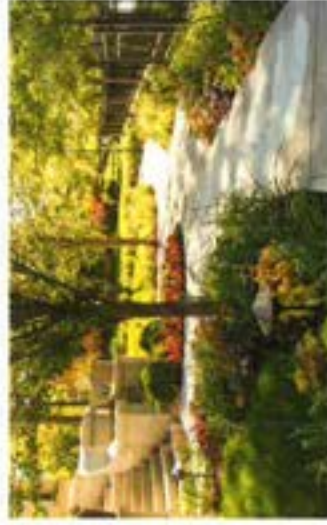
Figure 2-37. Circulation Path as it appeared in 2012 after completion. Credit: www.MGBA-Studio.com, 2022.

- ◆ Small-scale feature changes include removing the flagpole from the circular bed at South Temple pedestrian entrance and installing two new flagpoles. The Utah State flag was placed to the east and the national flag to the west (MJA Architects 2012). In addition, lighting was updated throughout the site and accent lighting added to the planting beds as seen in Figure 2-37.

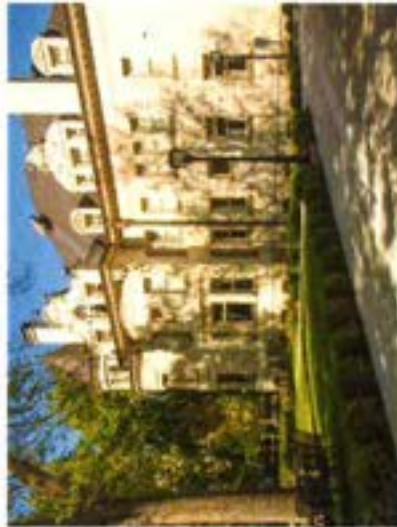
Figure 2-38. Kearns Mansion Boxwood Hedge, 2012 Design
Credit: www.MGBAStudio.com 2022.

- ◆ The Great Lawn was retained and defined by making planting beds more uniform along the north edge. A hedge of boxwoods was planted in this area to separate the carriage house driveway and the Great Lawn. However, the hedge was subject to ice melt burn and by 2021 several had died so a tall curb was installed to help protect plantings (Pypor 2022). The curb was extended to the opposite side of the path as well to meet up with existing curbing

- ◆ A break in the planting beds was included in the 2012 plan under the dining room window. This grassy area is often used to set up a podium for events (see again Figure 2-38). (Pypor 2022)

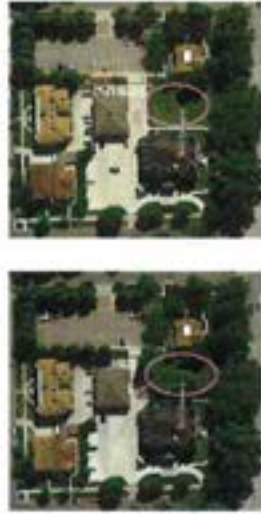
Figure 2-39. Great Lawn June 2013
Credit: Google Earth.

Figure 2-40. Great Lawn June 2015
Credit: Google Earth.

- ◆ Several trees were removed and locations noted on the 2012 Demolition Plan. (MJA Architects 2012). However, many trees were retained including three mature trees in the Great Lawn. Google Earth images show they were eventually removed sometime between June of 2013 and June of 2015 (see Figures 2-39 and 2-40). (Google Earth 2022)

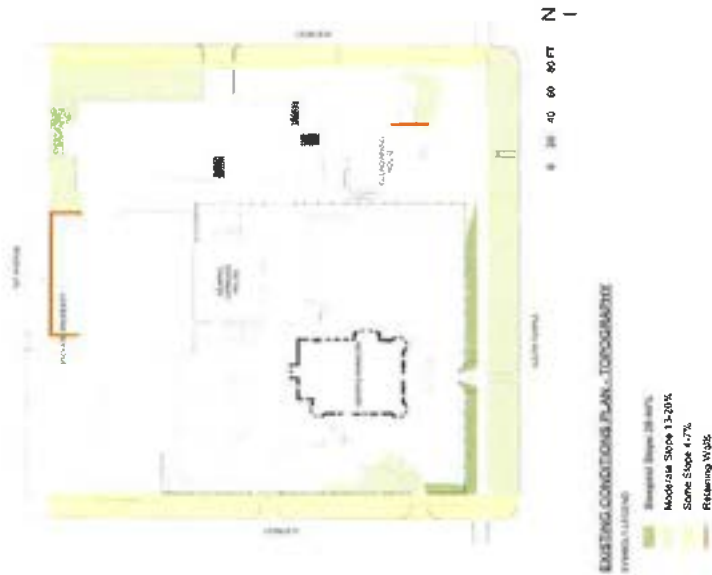
Figure 3-1. Existing Conditions Plan - Topography

West Streetscape: This area encompasses the curb cuts that allow access to the Kearns parking lot and cycle drive. To the east, the perimeter fence serves as a wall plane. To the west the remaining street trees help reinforce the edge created by the curb and provide an overhead plane.

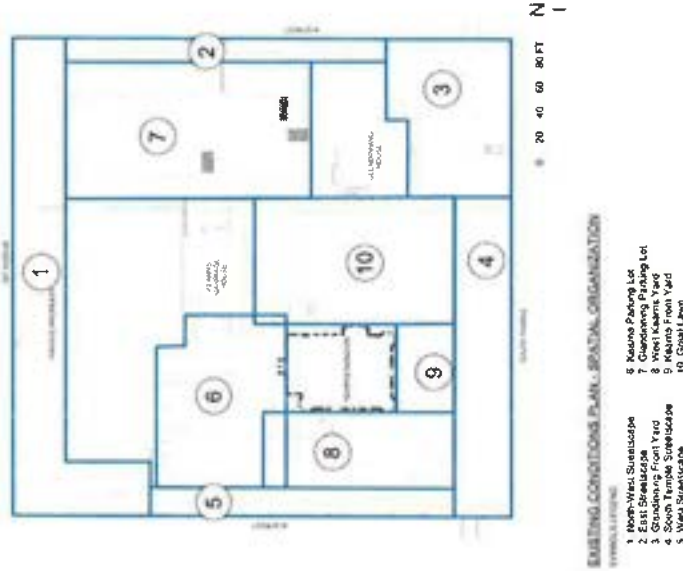
Figure 3-2. Existing Conditions Plan – Spatial Organization

Great Lawn: The Great Lawn is defined on the ground plane by the large open area of lawn that is bounded on the south and east by the perimeter fence. This boundary is reinforced by the vegetation that runs along the fence including the continuation of the row of ornamental cherry trees along the south edge. The east facade of the Keams Mansion makes up the wall boundary to the west. The line of force off this facade intersects with the line of force off the south facade of the carriage house, which makes up the northern wall of the space, to create the northwest boundary of this space. The change in material in the ground plane from the lawn to the paved drive isle south of the carriage isle is emphasized by the low shrub vegetation, however, this low vegetated mass does not function as wall plane to divide the space.

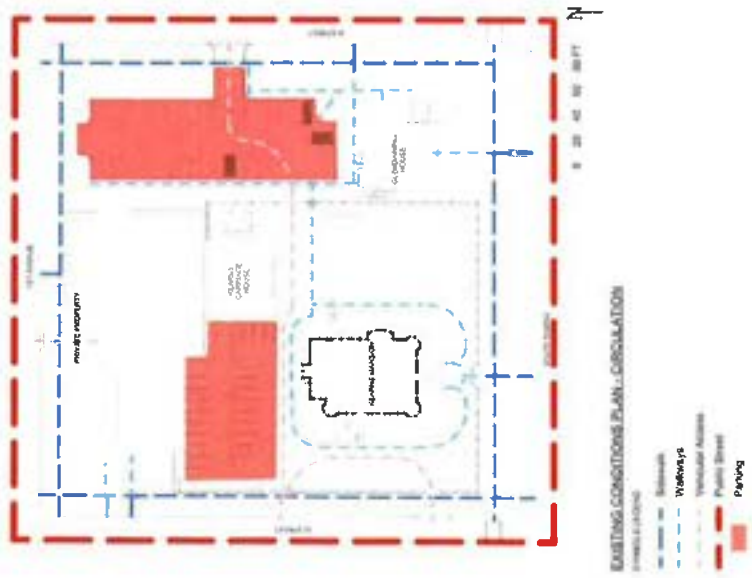
Figure 3-4. Existing Conditions Plan - Circulation

The block has traditionally been entirely used as residential but has since been partially converted for office use. This conversion can be seen in the landscape around the Kearns Mansion and Glendinning House through the addition of parking lots, the eastern driveway, the sculpture and adjacent Thought Garden patio, and the security fencing. The northern buildings remain in residential use and the associated landscaping reflects this. The Kearns Mansion landscape reflects the building's use as the official governor's residence/associated office space through the dedicated event lawn.

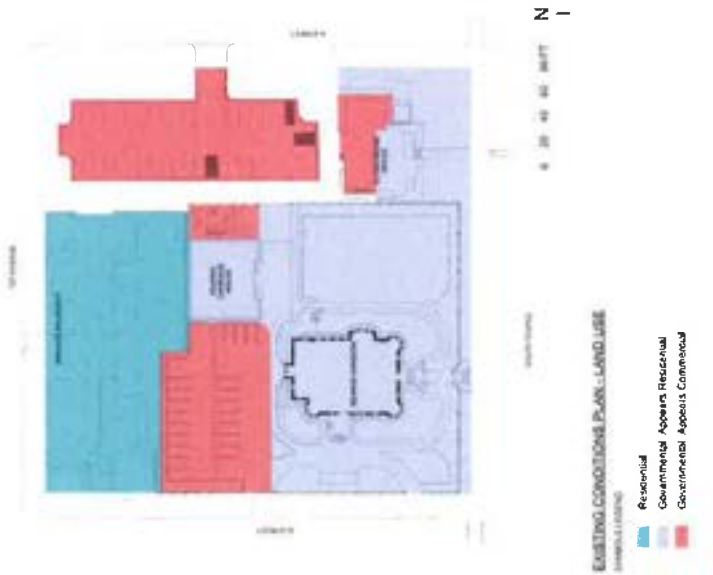
Figure 3-5. Existing Conditions Plan - Land Use

Views from the interior of the site looking out are limited by the mature tree canopy of trees both on and off the site. Prominent views looking into the site from the exterior are focused on the historic architecture. These views into the site are especially prominent from the South Temple corridor. Within the site there is a designed focal point view is of the sculpture installation looking south down the pathway that culminates in the sculpture.

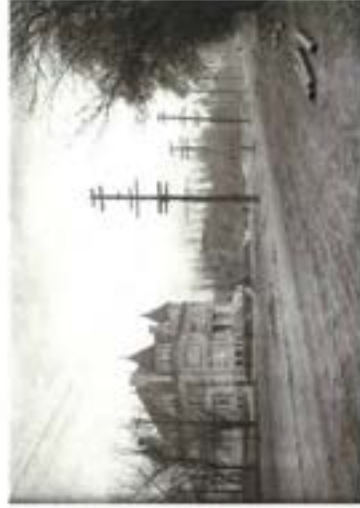
Figure 4-1. 1905 overview of Block 407 looking east-northeast. Note overall terrain and terracing of lots for the Kearns, Mason and Epley-Glenn-Harding House. Credit: Utah State Historical Society.

The current topography of Block 407 is substantially similar to that during the period of significance. The overall slope of the terrain has been maintained, as has the terracing of most the developed parcels (see Figures 4-1 and 4-2 for a photographic comparison). The exception to this is the northeast quadrant of the block where the parking lot is located. Here, the terracing that existed at the locations of the three historical dwellings was removed after the structures were demolished. The land was graded to match the overall slope of the topography, which eliminated the evidence of the historical landscape features but effectively reconstituted the pre-1847 slope of the terrain.

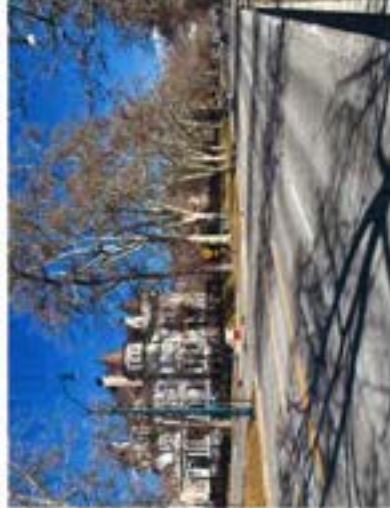
Figure 4-2. 2022 comparative view of Block 407 topography.

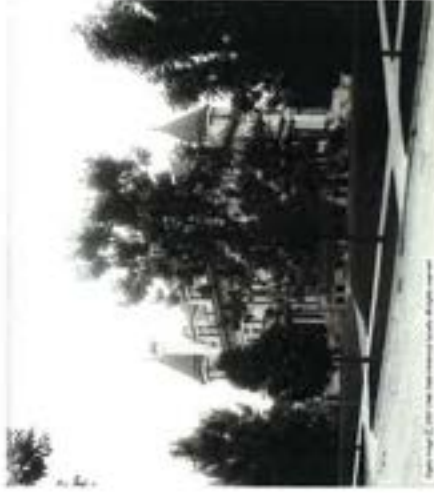
Figure 4-3. 1914 image of the Keams Mansion showing view becoming obstructed by maturing trees. Credit: Utah State Historical Society.

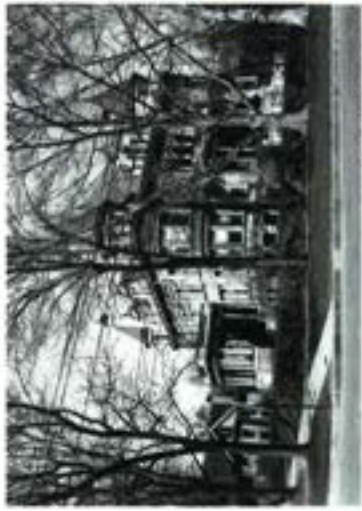
Figure 4-4. 1945 image of the Kearns Mansion showing mature trees effectively eliminating distant views.
Credit: Utah State Historical Society.

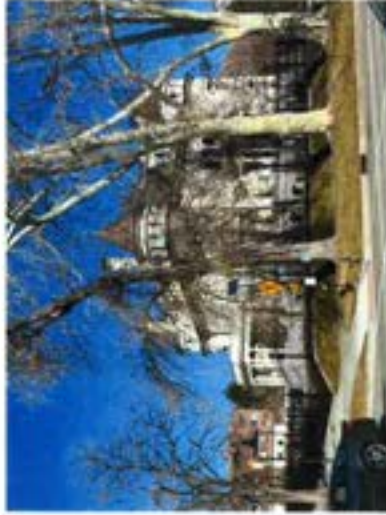
Figure 4-5. 2022 image of the Kearns Mansion showing mature trees effectively eliminating distant views.

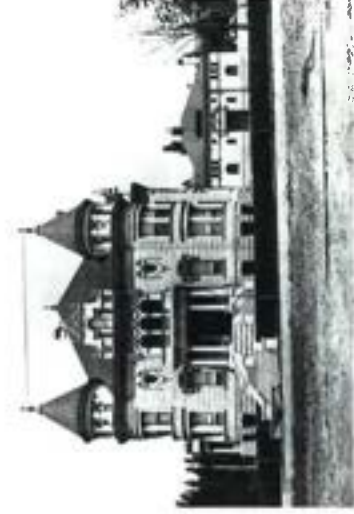
Figure 4-6. 1907 image of the Kearns Mansion showing unobstructed view of the Carriage House.
Credit: Utah State Historical Society.

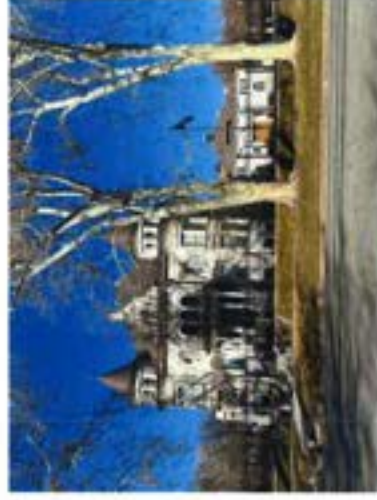
Figure 4-7. 2022 image of the Kearns Mansion showing partially obstructed view of the Carriage House.

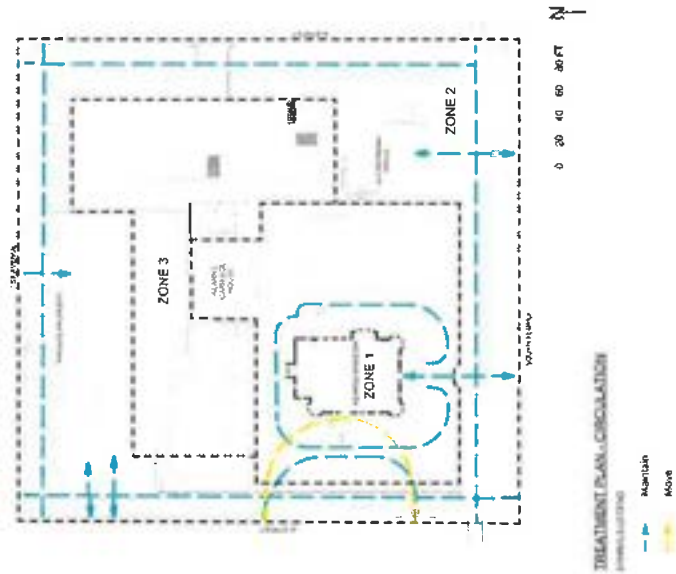
- ◆ Surface parking, if required, should be located in Zone 3.

Figure S-3. Treatment Plan - Circulation

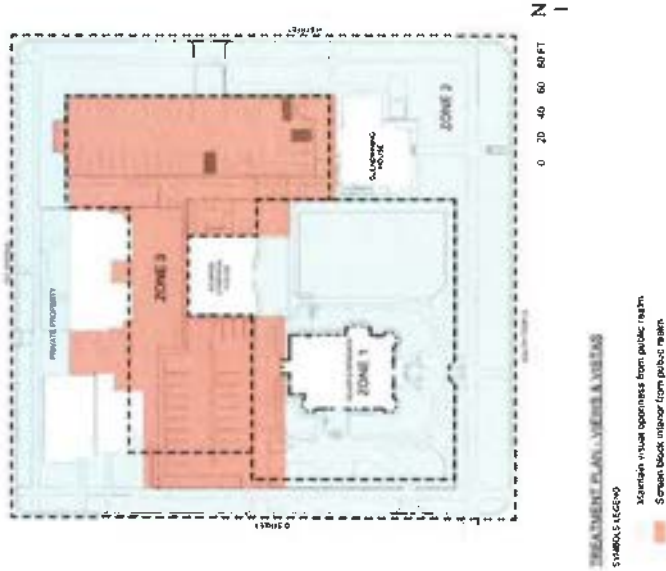
- Zone 2
 - ◆ Maintain visual openness of other homes from the public realm.
 - ◆ Minimize the use of tall vegetation or other elements that might obstruct view of other homes from the public realm.

- Zone 3
 - ◆ Screen interior block uses from streetscape/public realm.

Figure 5-4. Treatment Plan – Views & Vistas

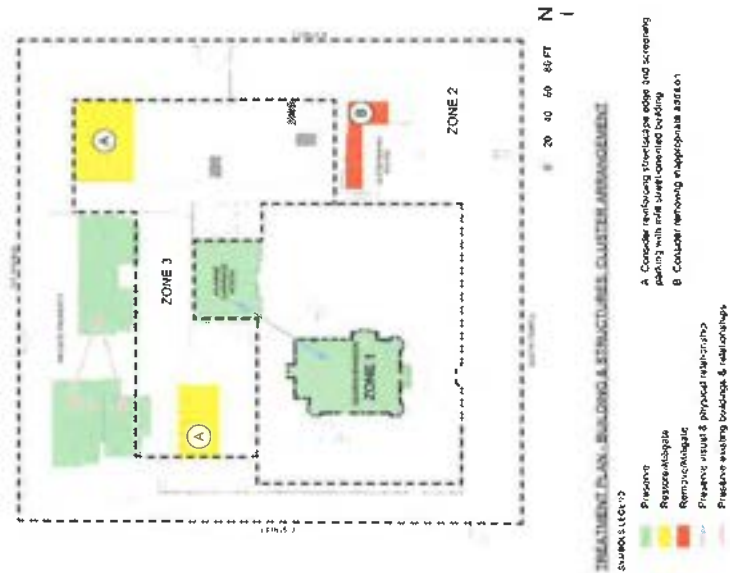
- Zone 1
 - ◆ Preserve the visual and physical relationship between the Kearns Mansion and Carriage House.
 - ◆ No visible additional buildings or additions should be added to Zone 1.
- Zone 2
 - ◆ Preserve the existing homes lining the perimeter of the block.
 - ◆ New buildings should be consistent with existing building patterns and relationships including:
 - ▶ Setbacks,
 - ▶ Scale, and
 - ▶ Primary facade and building entrance oriented toward the street

Figure 5-5. Treatment Plan – Buildings & Structures Cluster Arrangement

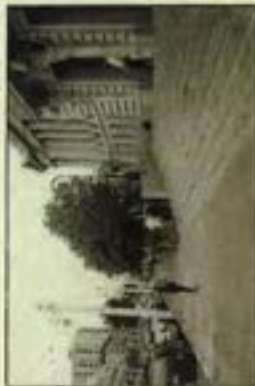
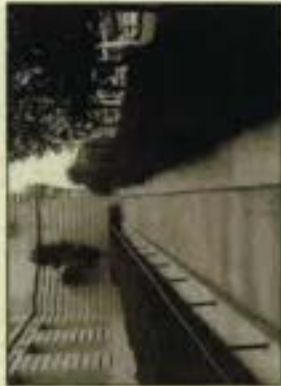
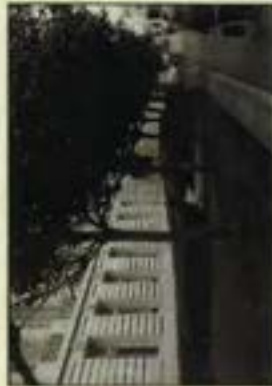
To comply with the ADA, an accessibility station was provided for at San Francisco's City Hall. The design preserves the historic "hodge" along the building foundation, and conceals the new ramps and stairs. The station is designed to provide building elevation, the simplicity of the facade and its Application planing have been performed. (Author, 1993)

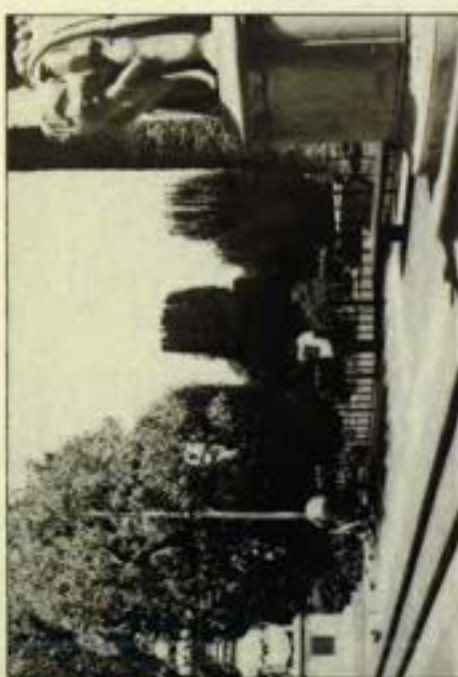
These include historic landscapes in a rural town in Switzerland. Columns have been reconstructed to integrate with existing, older masonry (source: author, 1993)

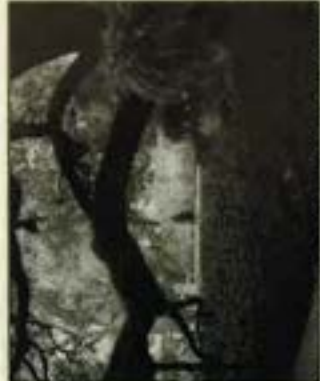
Fig. 10-10. A masonry wall in disrepair and being stabilized. (Author, 1997)

Features within a cultural landscape may need to be stabilized or protected through preliminary measures until additional work can be undertaken. Stabilization may include structural reinforcement of a masonry wall, or the application of a protective coating of a new, water-repellent material. This work should be done as little as possible from the cultural landscape's appearance. Although it may not be necessary in every preservation project, stabilization is nonetheless an integral part of the treatment. Preservation, if it is equally applicable, if circumstances warrant, for masonry, woodwork, plasterwork, and other materials. Such actions would include the installation of temporary bracing around deteriorated steel members or the electrical grounding of a tree.

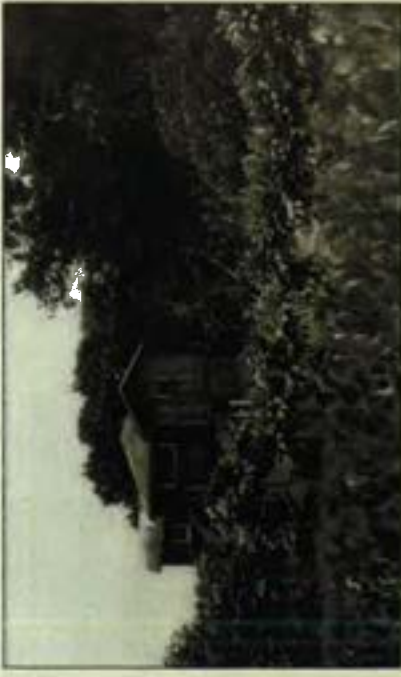
Fig. 10-11. A well-preserved, early 20th-century building in the 1800s. In an effort to protect the building from fire, the County of Maui, Hawaii, placed an ornance (a fireproofing material) in 1900. (Author, 1997)

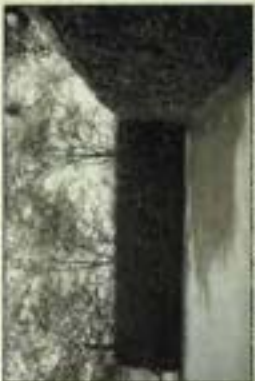
Fig. 10-12. A wooden oak-oak deck painting to maintain the form of a hedge fence. (Author, 1997)

After recording, inventory, and establishing historic features and materials that are important and must be retained, maintaining them becomes important. For example, maintenance includes treatments such as removing rust from an iron light standard, repointing a stone foundation, re-application of protective coatings, a wooden oak-oak deck painting to maintain the form of a hedge fence, or pest control, monitoring the age, health, and vigor of plant materials, or the cyclical cleaning of drainage inlets. As a foundation for these decisions, an overall evaluation of a cultural landscape's existing conditions should always begin at this level.

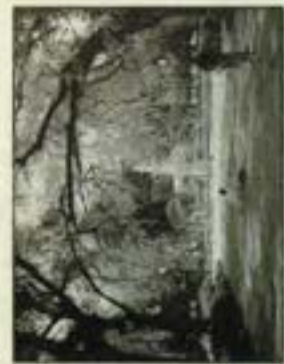
This close-up shows a section of a wall at Alquist Park, San Francisco, Oregon, that has been treated to fight mold. The mold has been removed, but the underlying structure has been damaged.

When the existing conditions of character-defining features and materials require additional work, their repair is recommended. Preservation strives to retain the maximum amount of existing materials and features while utilizing as little new material as possible. Consequently, guidance for repairing historic features, such as vegetation, boughs with the least degree of intervention possible, such as pruning a tree to lighten its canopy (see opposite); or, in some cases, pruning back a shrub to the ground to encourage vigorous and healthy new growth. Similarly, within the historic Preservation, patches of a historical structural system could be reinforced using contemporary materials. A capstone on a retaining wall, or a board in a wooden walkway, may be repaired with contemporary replacement parts. In all cases, work should be non-destructive, physically and visually compatible, and documented for future research.

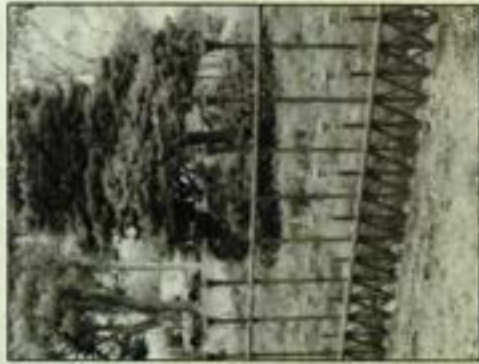
Cracks were made to appear a proper number of feet below using the common method of laying out squares. St. Louis, Missouri (author, 1989)

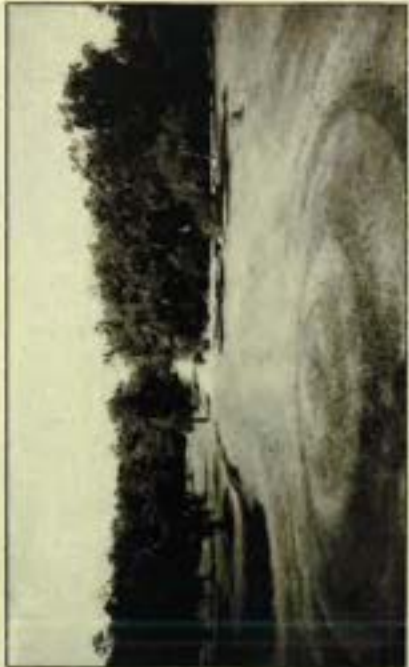
The landscape at Clayton Hill in Charleston, South Carolina, reflects seven generations of family ownership. The circular topographic addition along the approach road has been preserved. Future research is now underway to understand the date of introduction and the design intent. (Hector, 1994)

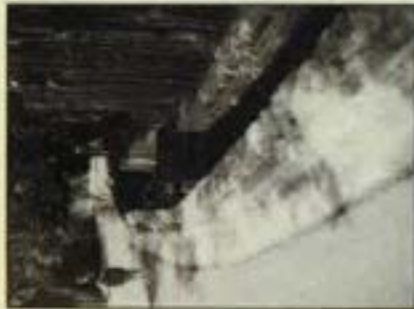
The integrity of this historic irrigation system in San Antonio, Texas, (shown) had been threatened by tearing it clean of soil layer and masonry supports. (Lambert, 1982). The plan for the Katabaka Irrigation System in East County, California, (right) illustrates a work-around for the system's structural problems. The plan also includes a detailed survey, field notes, and a variety of other types of historical photographs.

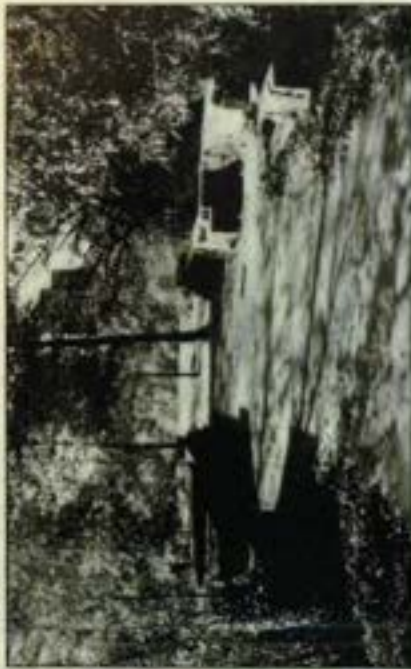
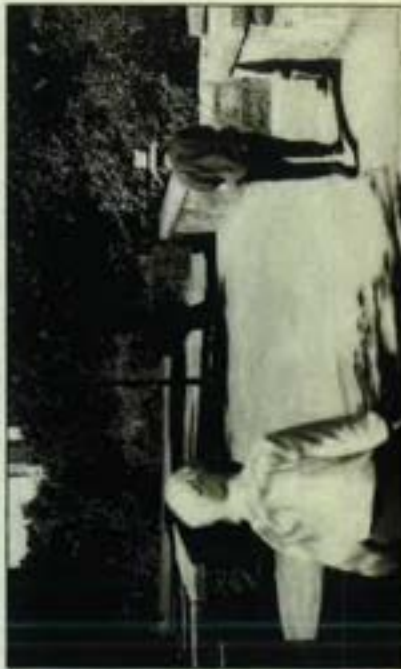
Many of the streets along the historic Bridge along Boston's Roxbury Neck follow the study Row below. As part of the project work, these streets were widened from the water and raised. In addition to several new stones that were cut to either to replace missing stones that were lost. (author: 1888, 1904)

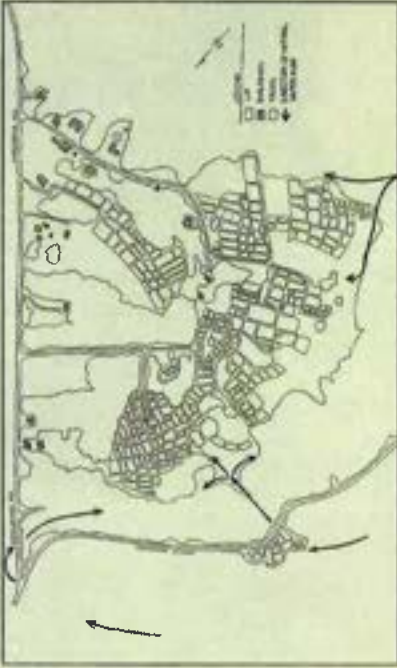
The central portion of the image probably contains the most highly disturbed concentration of topographic features. This is the area that should be most carefully monitored and protected. Some of the features are likely to be in need of periodic access for mowers and seed-bomb windows. This plan document will monitor the area surveyed in the Wahayuta Cemetery (Group 70).

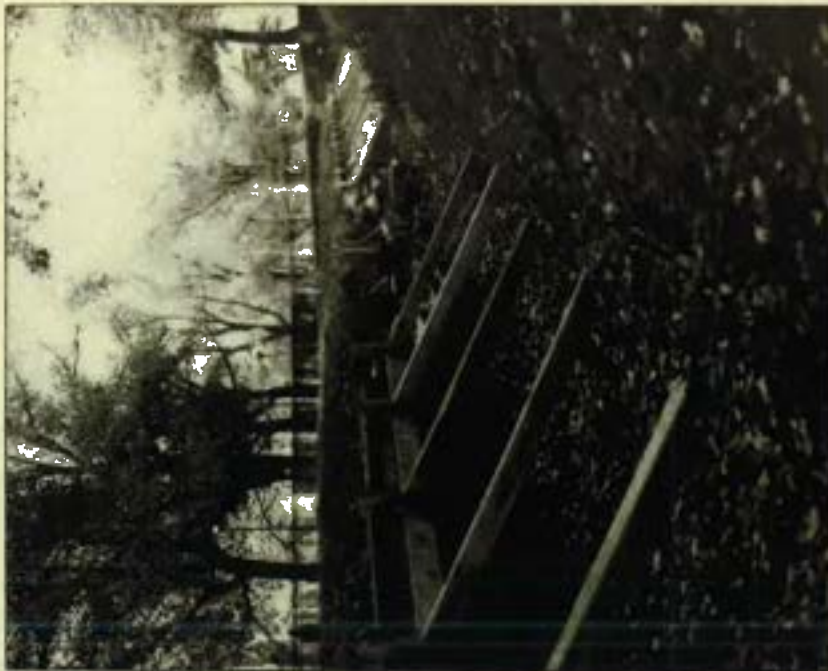
Located on the southeastern corner of Boston Common, the Central Burying Ground (1754) is the largest early Buriall ground in Boston, Massachusetts. One of the most outstanding topographic features, a tree-enclosed mound (one of the landmarks in the 20-year study) followed. Prior to its restoration, (see page 105) further elevations were created with a wooden string and bench system. This providing the final collapse. (Boston Parks & Recreation, Middle's Burying Ground website)

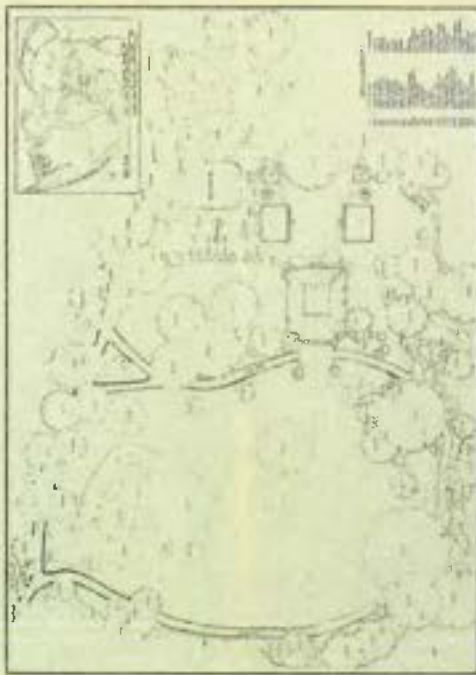
The surviving woodlot materials were all documented for Missouri National Historical Park in Winona, Minnesota. The plan for the core area of the site was property documents of trees, shrubs and vines, including several historical trees. Two sketches illustrate the 20-year-old and the 50-year-old, both in the original landscape area. This documentation project provides a sound basis for future preservation and management decisions. (HABS)

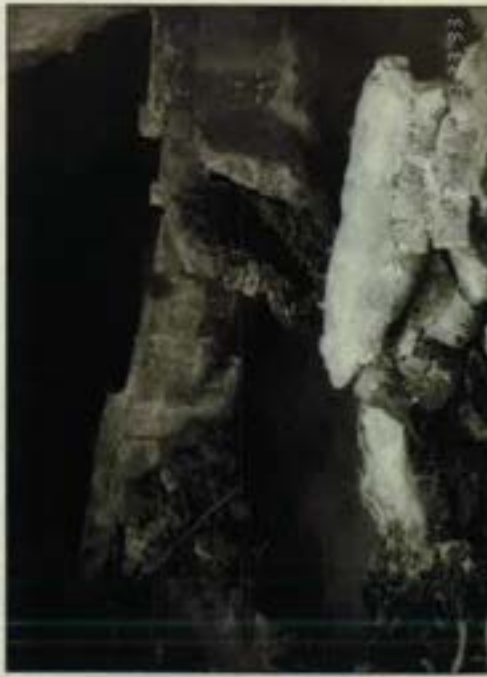
As part of a cultural landscape study, three sections of a second dam were excavated at the Ozark National Scenic Riverways near Van Buren, Missouri. These preliminary findings suggest the former land uses of the region. (courtesy USFS)

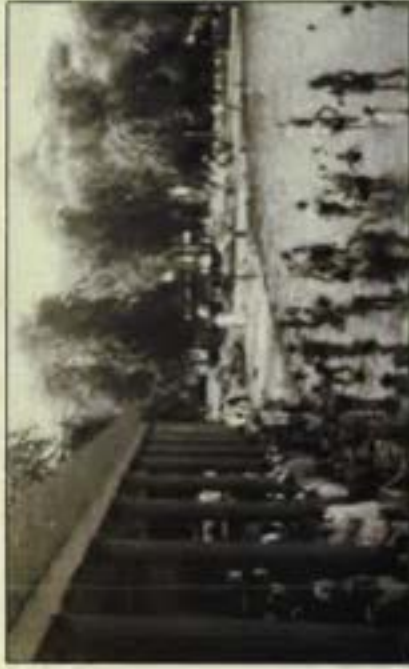
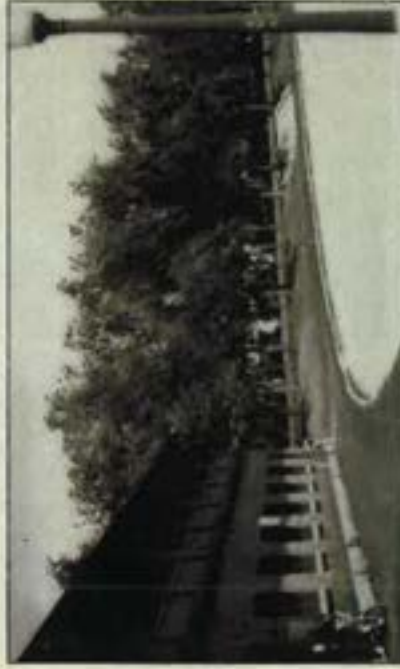
Photo rehabilitation project work that excavates existing pond in Lincoln Park in Buffalo, New York, was evaluated to understand the historic design and use. It was determined that, although the pond and postbox were irregular, they possessed a high level of regularity. (LANDSCAPES)

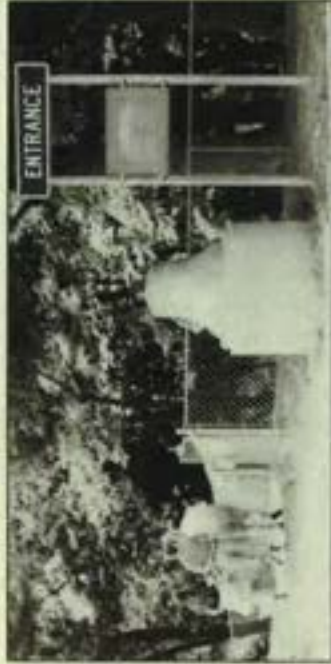
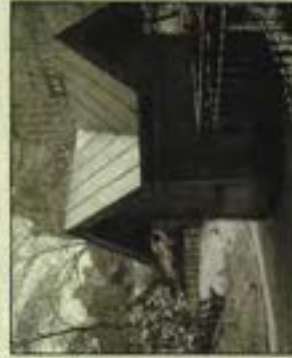
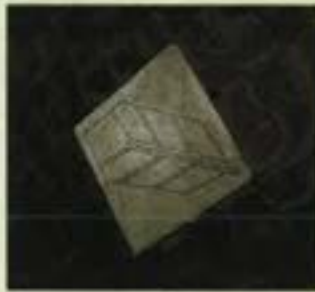
The sign and treatment of furnishings should always be carefully considered. Here at Eagle Nest, the historical stone is a concrete log. In fact, the history of the sign is illustrated by the "not recommended" example, not all signs need to be on a large scale to communicate the integrity of a resource. Clear, to read in a landscape's interpretation, is a sign that may be used to identify a resource. Successful examples have included a carefully placed sign, such as the sign at the entrance to the National Park at Point Reyes. California Jones right, a tree route marker, such as the one at the entrance to the National Park at Point Reyes. Jones' work is a good example of a sign that is both functional and aesthetically pleasing. This and in Central Park across hundreds of visitors, day, and is easily replaceable (bottom right).

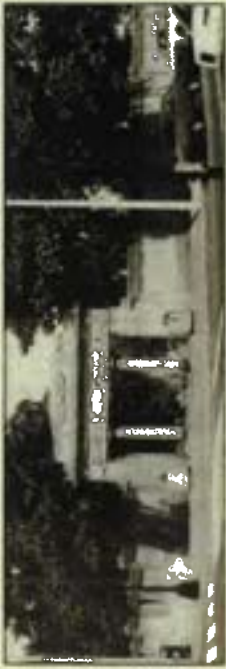
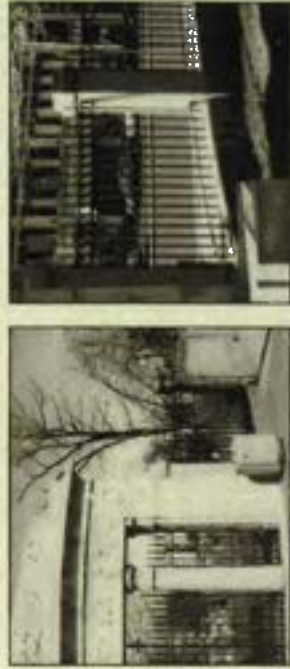
A section of the wall surrounding the Cornwheat North Burying Ground in Massachusetts was in a state of advanced deterioration. Roof, gutter, and foundation work were required to stabilize the structure. The area of wall between these parts was replaced with a new, decorative wall. The new wall was designed to be visually compatible with the original wall, allowing for visual access into the burial ground, where it was previously enclosed (photos: 1983 and Boston Photo)

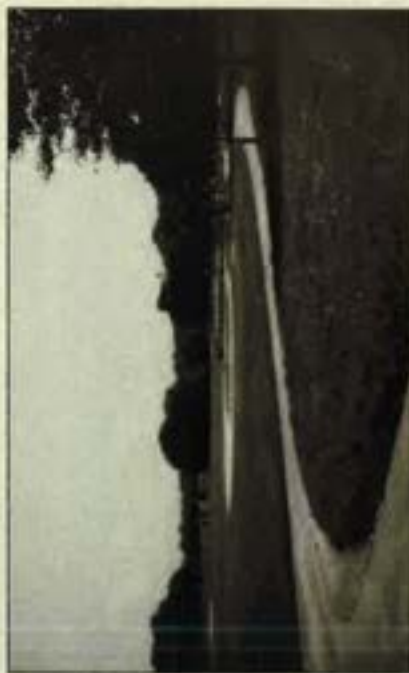
As part of a comprehensive rehabilitation project for Prospect Park's Long Meadow in Brooklyn, New York, a non-historic turf field was relocated by permission of impact on the great greenward. Here, the bedforms and associated banks are realigned along a wetland edge. The new fencing is simply in scope and parallel tracks to provide the viewshed. (Prospect Park, Jersey)

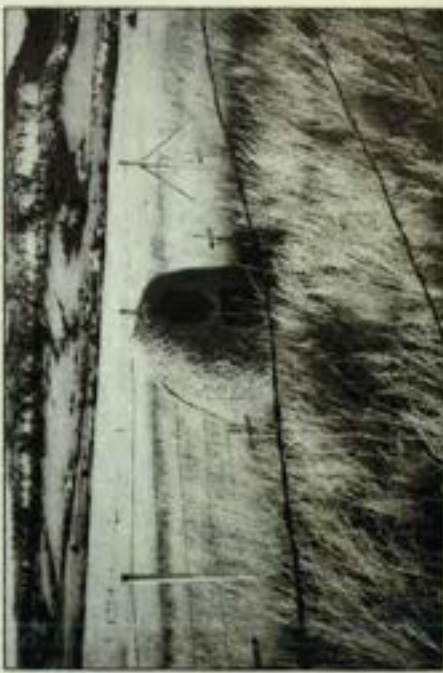
Communicative masonry, such as the one that notes the emigrant graves at Fossilifer Pass on the Oregon Trail, (near Steeds Buff National Monument, Nebraska) were installed by the Daughters of the American Revolution. The historic masonry and granite were protected with a polymer waterproofing spray. (Copyright 1993)

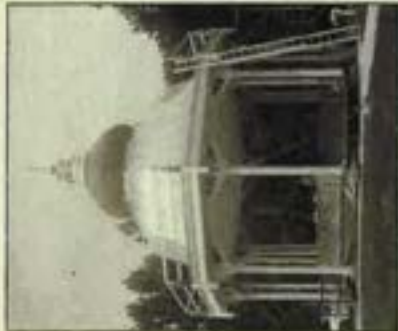
A section of a historic wall of the Hwayi Hall in Abano, Ohio, was in need of restoration. First, the fabric replacement of a section of the wall was undertaken using surviving stone and masonry that matched the old in form, size, and color. Compatible substitute material must also have been used. (Author, 1993)

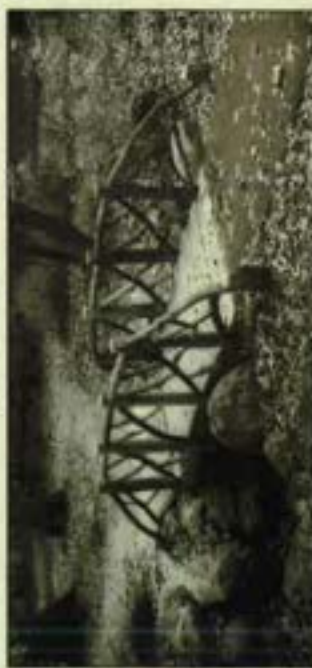
The steel structure in Central Park's Bethesda Fountains has been re-created on the basis of historic documentation. The design meets current code requirements, yet replicates the historic appearance, while utilizing compatible substitute materials (Central Park Conservancy). The original structure for the landscape of the J. L. Spurr Stonehouse Property, Greenwich, Connecticut, Italy is restoration to the original pattern (stone, brick, masonry) using preserved historic materials and new masonry blocks on the alignment of the original walls. For example, grass relationships to the historic, existing and high 'new' stone masonry (Landscape Architecture).

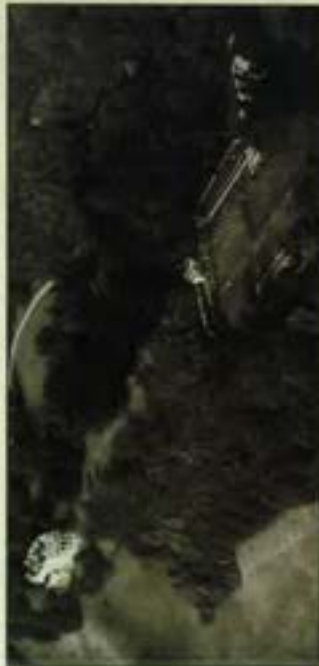
The spatial organization and land patterns of the 214-acre landscape at the Woodlark Mission National Historic Site in Hyde Park, New York, are clearly visible. This historic aerial photograph from the 1930s (above) provides excellent documentation of the spatial organization during the landscape's period of application from 1830 to 1839. Project work reestablishing the meadow and forest areas developed from 1930 to 1970 preserve and enhance the restoration plan. (Left) (Woodlark Mission National Historic Site and NY State Parks)

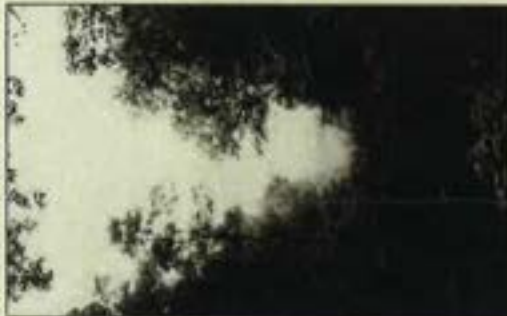
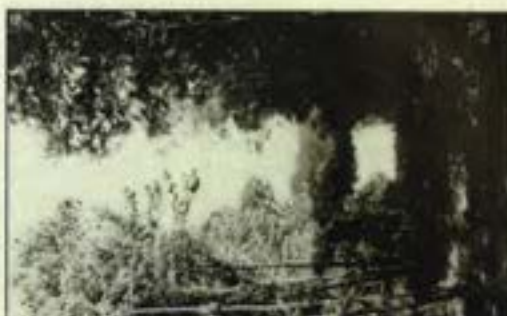
Leaf density, spatial organization at Star-Hyatt Hall had changed due to a lack of maintenance (left). The view, which has recently been reestablished, creates a strong visual link between the house and the larger landscape, originally designed by Warren H. Manning (right). (Star-Hyatt Hall Foundation)

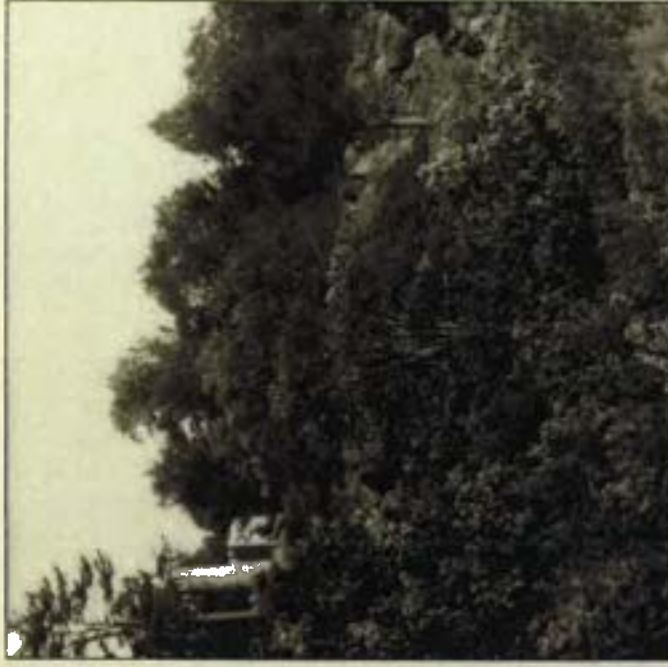
The landscape of the Valley of Geocology, Pennsylvania, has evolved dramatically since 1983 (opposite left). Open areas, for example, regularly receive soil and organic material from the surrounding woods. The area was restored with rocky plants and logs to resemble the original landscape. To ensure that the landscape is restored to its original appearance, the second day after the first day, the site was planted with native plants and the importance of the land to the ecology was emphasized. (courtesy GBS)
