BLOCK 407 MASTER PLAN

PROJECT NAME: BLOCK 407 MASTER PLAN
GSBS PROJECT NUMBER: 2-27-2022-04
DATE: September 9, 2022

COMMUNITY DEVELOPMENT
SALTLAKE COUNTY
PUBLIC SERVICES

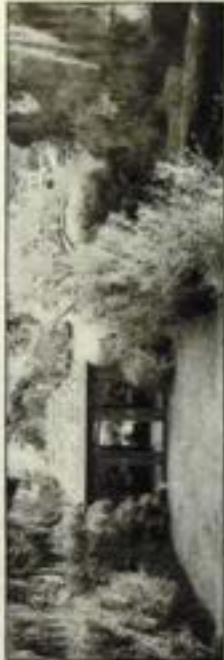
The garden walls constructed during the 1920s and 1930s at Shadow-on-the-Tribe in New Haven, Louisiana, also help to define the historic landscape. As part of the restoration project, the creator used a mixture of earth and Portland cement to reconstruct the walls and new stone (locally found), a gravel top coat is placed and called for (book cover and called for book) (Shadow-on-the-Tribe)

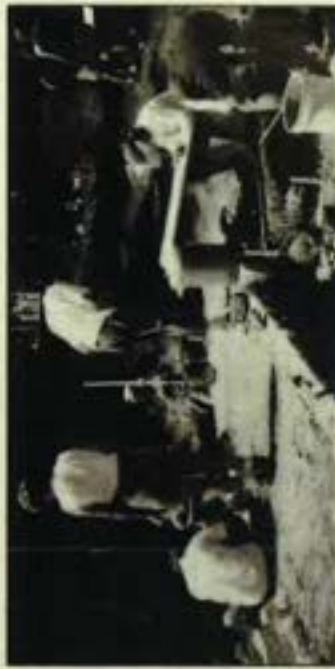
At the Joseph Castle in Orléans, New York, the location of pools believed to be part of the original design by Mrs. Johnson was confirmed by ethnology. (Judy Hight)

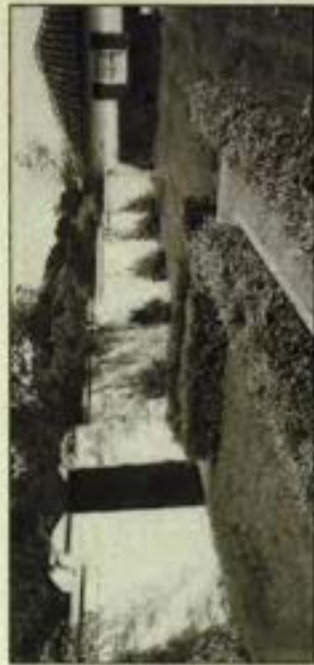
At the Eugene O'Neill National Historic Site in Danvers, California, wheelchair ramps were installed for wheelchair access (Courtesy NPS).

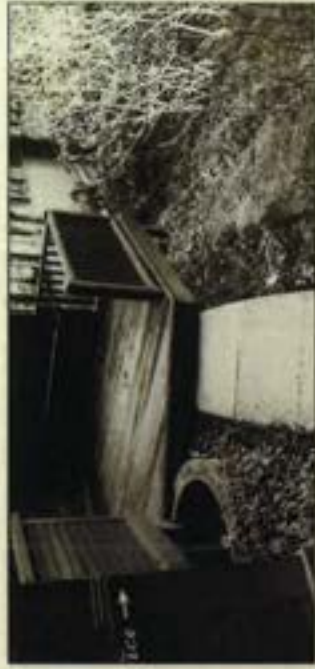
Modifications to the entrance of the Freedom Cafe, Omaha National Historic Site in Browline, Massachusetts, meet accessibility requirements and maintain historic character and architectural materials (Courtesy NPS).

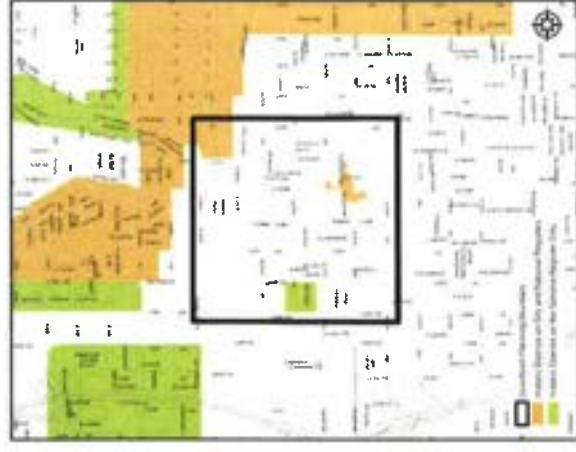
FIGURE 3: LOCATION OF LOCAL HISTORIC DISTRICTS AND DOWNTOWN PLANNING AREA

Source: Salt Lake City Planning Division GIS, 2009

FIGURE 3. LOCATION OF LOCAL HISTORIC DISTRICTS AND DOWNTOWN PLANNING AREA

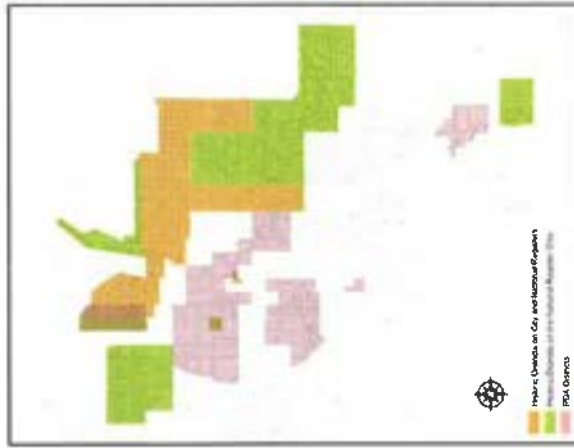
Source: Salt Lake City Planning Division GIS, 2009

FIGURE 4: LOCATION OF LOCAL HISTORIC DISTRICTS RELATIVE TO RDA PROJECT AREAS

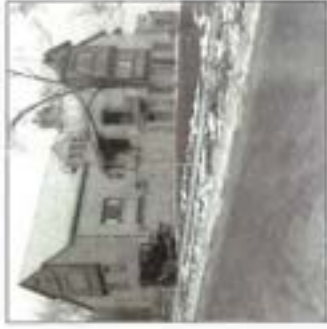
Tudor Revival

- steeply pitched roof
- cross-gabled roof lines
- decorative half-timbering
- decorative masonry
- arched doorways
- casement windows, often with leaded, diamond panes
- projecting entryway that follows slope of front gable
- rolled edges on roofing (an attempt to imitate tuck)
- use of stucco or brick

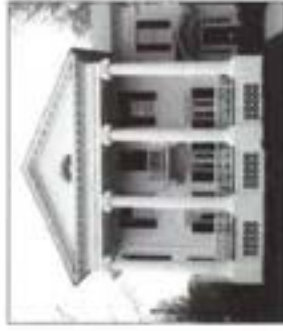
Neoclassical Revival

- c. 1895-1925
- full-height porch with a pediment, round columns with complex capitals. In some instances the porches are curved porticoes
- flipped roofs
- eaves with dentils, modillions, prominent frieze
- shutters
- paneled doors surrounded by pilasters and a pediment
- double-hung windows, usually one-over-one, but sometimes six-over-six or six-over-one
- low porch rails with turned balusters

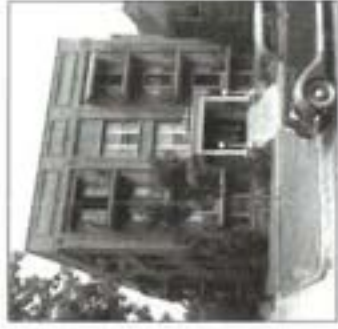
A double-loaded corridor apartment building.

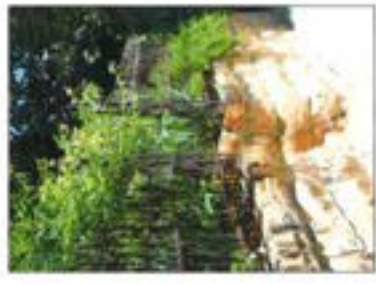
Historic fences, often of wrought and cast iron, and original retaining walls provide visual richness and a sense of time in the streetscape.

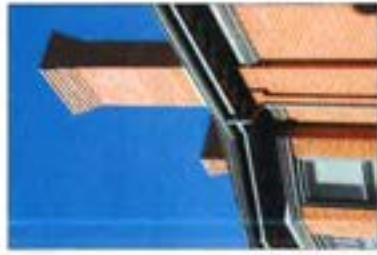
Attention to the brick texture and the pointing profile are used in this case to define the wall, the window bay and the chimney.

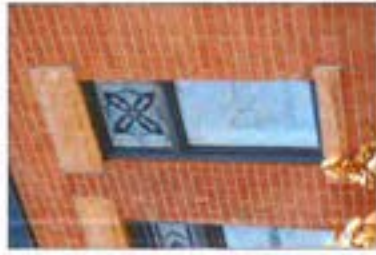
Matching the existing brick pattern or bond and the composition of the mortar help to ensure the integrity of the brick and stonework and consequently architectural character.

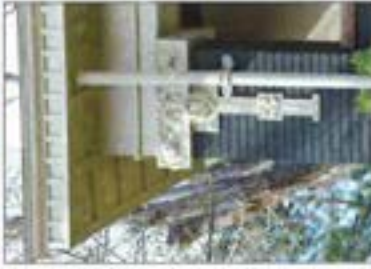
Chosen for its qualities of resilience and adaptability, metal has provided a visual medium for fine decorative detailing, including cornice profiles, soft awnings and railings.

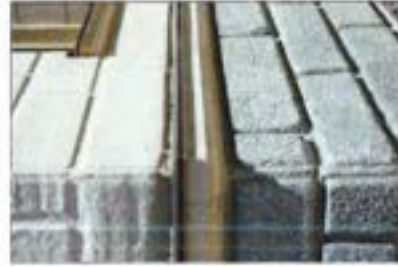
A new mortar profile demonstrates a sense of architectural time and history.

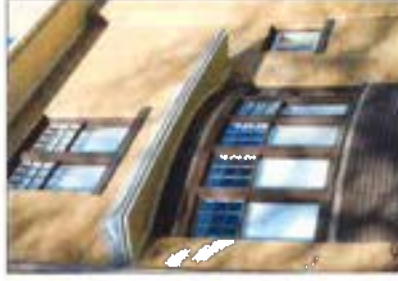
Great care is required to ensure that if cleaning is really required this is achieved using the gentlest means possible, and not using abrasive methods. In contrast to the case shown above, the brick surface below has been completely destroyed using abrasive cleaning methods.

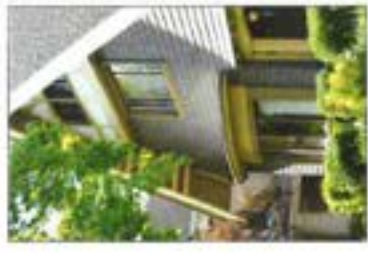
Colour can be used to complement the texture and qualities of the materials and detailing

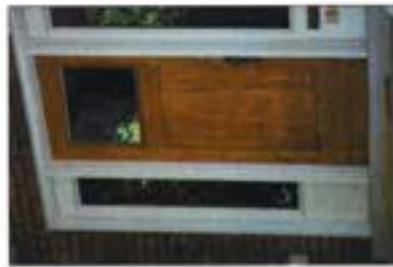
This single paneled oak door reflects the simpler forms and detailing of the Arts & Crafts design philosophy.

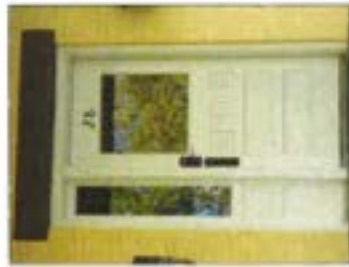
The paneled oak door is caked in the adjacent sidewalk paint, and together with the door frame detail create a coherent design composition.

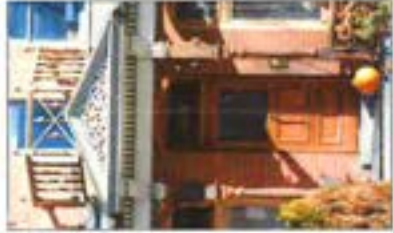
The design composition, materials and detailing of the entrance contribute to the character of the building and its context.

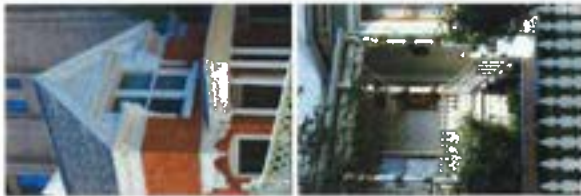
Original and unexpected repair materials can help in defining the form of a building in the present day.

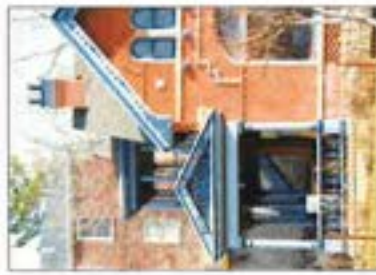
Maintaining the composition and architectural appearance of an original porch (detail) following reconstruction efforts in the past (above).

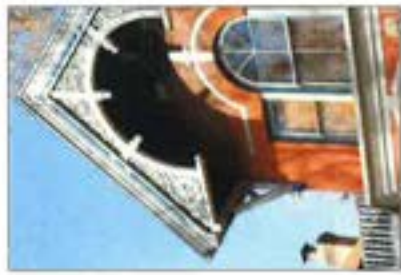
Using non-pairable substitute materials may preclude enhancing architectural details through a carefully considered color scheme.

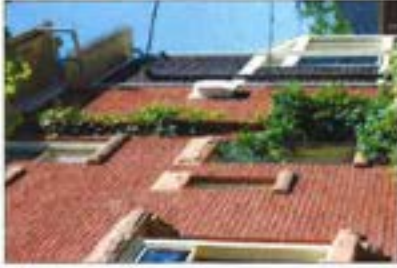
A new addition which is subordinate to the house and distinguished by height, materials, foundation and unique profiles and details.

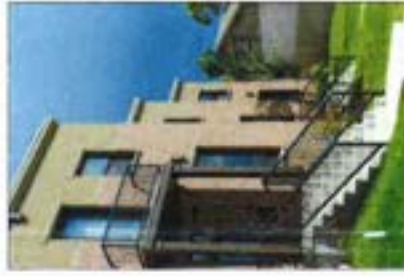
A stone vertical emphasis is created by the facade modules, tall entrance porchway and the composition and proportions of doors and windows.

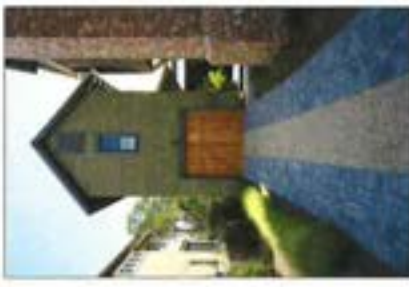
Although higher than would normally be appropriate in Salt Lake City historic residential neighborhoods, the square openings in this tall gabled building effectively create a central focal accent for this building.

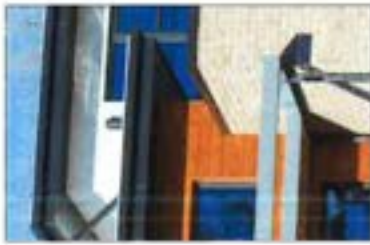
An interplay of diverse, nontraditional materials like brick, stucco, and color can help to mitigate simple rectangular forms with the palette of materials and colors of the context.

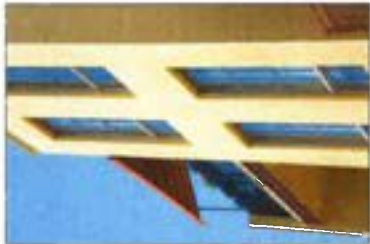
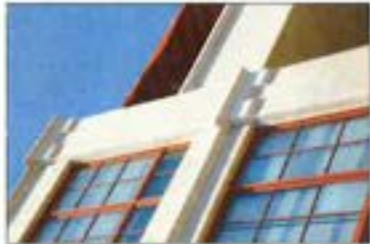
Window proportions, reveals and frame details can add visual strength and durability.

Window openings often provide a considerable degree of modeling to the building facades, with a distinctive recess (window reveal) of the plane of the window from the plane of the wall. This characteristic enhances the visual strength of a facade, conveying a sense of the depth and solidity of the wall and distinct areas of shadow which change with the time of day and the season. This recess also helps to shelter the window and the window frame

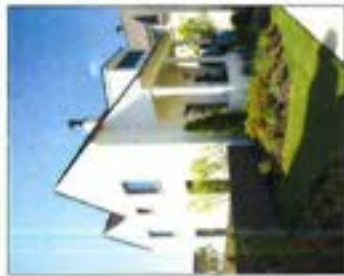
Window reveals and contemporary detailing to the porch and front corner windows add both a visual strength and human scale interest.

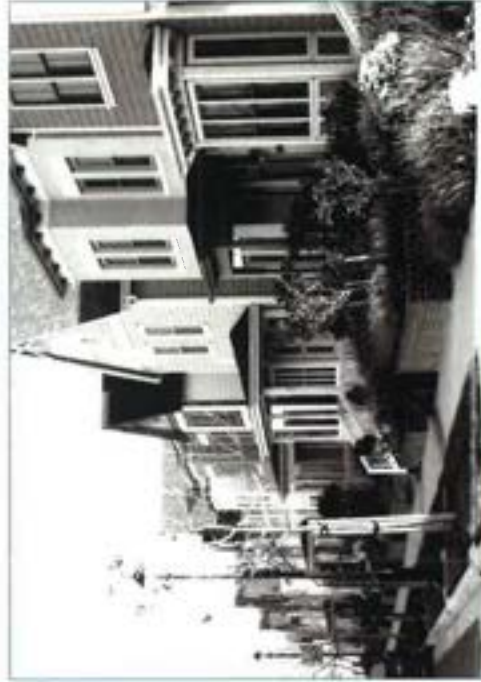
Street Facade Evaluation

This is an illustration of the application of the Design Guidelines for New Construction for a Street Facade.

The design guidelines for New Construction are summarized above under the principal topic headings, with the numbers of the pertinent design guidelines.

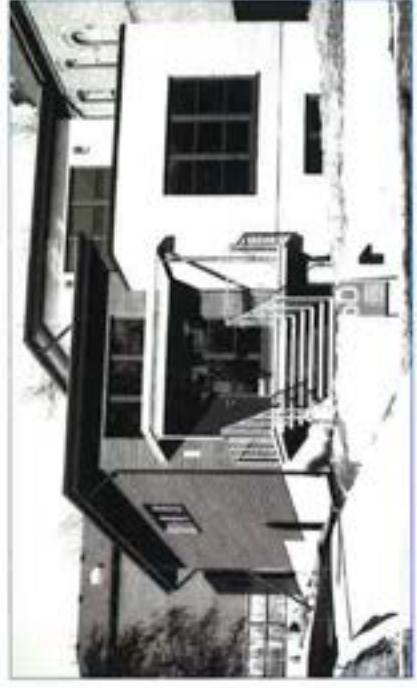
Building Evaluation

This is an illustration of the application of the Design Guidelines for New Construction for an individual Building in context.
The design guidelines for New Construction are summarised above under the principal topic headings, with the numbers of the pertinent design guidelines.
The facing page evaluates the rule and 'performance' of the design guidelines in the composition of this building, with the number reference relating to the design guideline topic above.

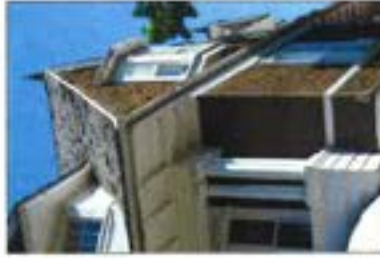
Wood shingles help to unify both walls and roofscape, creating visual feature as a background to Classical detail.

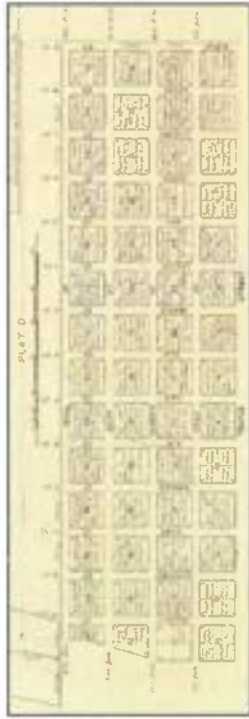
Figure 2-2. The original 56 blocks of Plat D. Credit: Nicholas G. Morgan, Sr.

Archives and photographs from the arrival of Anglo settlers in the valley and the first few years of settlement seem to confirm that the future location of Block 407 was dominated by sagebrush and grasses (see Figure 2-2).

Planting of the Salt Lake City continued in sequence with Plat B being located immediately east of Plat A and having its northern boundary on the south side of what is now South Temple Street. Plat C was located immediately west of Plat A, and Plat D (see Figure 2-2), which encompassed the southern portion of today’s Avenues neighborhood, including Block 407, was platted immediately north of Plat B, on the north side of South Temple Street. While the exact dates that Plat D was surveyed are unclear, it is evident the survey occurred sometime during the early-1850s. This suggests that lands in the Avenues area remained substantially undeveloped during the first several years of settlement. Given the natural occurrence of steppe grasses in the area, it is extremely likely lands in the future Avenues neighborhood were used as communal grazing lands for livestock prior to the actual plating of the neighborhood.

By 1857, the survey Plat D was completed and filed by city and territorial surveyor Jesse Fox. It encompassed 56 blocks in the northeast quadrant of the city on the north slope known as the "dry bench." Much of this area was within the large estate of Brigham Young. The layout of Plat D marked the first deviation from the Plat of the City of Zion but was still laid out on a strict north-south/east-west grid. Blocks of Plat D were surveyed to be 20 rods square (2½ acres) with streets at five rods wide (82½ feet) and sidewalks at 10 feet wide. These all deviated from the Plat of the City of Zion standard of 40 rods square (10-acre blocks), eight rods (132 feet) wide streets, and 20-foot-wide sidewalks and took an act of the Territorial Legislature to clear the plat from violating state law for land surveys. The atypical configuration of Plat D was likely an adaptation to the relatively steep terrain and lack of easily available freshwater in the area. The lack of water in particular would have made subsistence gardening on these lands more than challenging and less productive. Thus, the decision to plat smaller lots while still maintaining square blocks may have been based on the expected lack of productivity from lands in the area (Haglund and Notarianni 1980, 3).

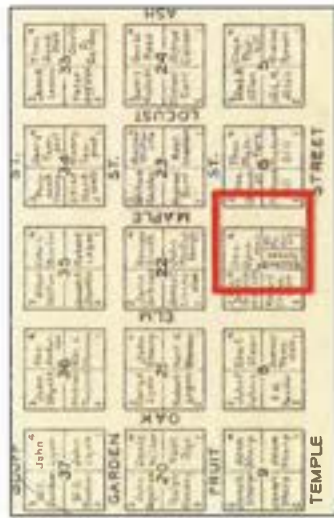
Figure 2-3 Excerpt from Plat D map showing Block 407. Credit: Nicholas G. Morgan, Sr.

were named Fruit Street, Garden Street, Bluff Street, and Wall Street from south to north. South Temple Street, the centerline of which formed the boundary between Plat D and Plat B, was simply named as Temple Street, though Sanborn fire insurance maps of the 1880s refer to it as Brigham Street. By 1885, the names of the east-west streets were changed to First, Second, Third, and Fourth streets, and the names of the north-south streets had been changed to their present alphabetical names. These changes were not officially ratified until 1907. (Haglund and Notaranni 1980: 3) Prior to changes to the street names, Block 407 occupied what was designated Block 7 of Plat D (see Figure 2-3). It was bordered on the north by Fruit Street (now 1st Avenue), on the east by Maple Street (now H Street), on the south by Temple Street (now South Temple), and on the west by Elm Street (now G Street). The first owners of Block 407 included:

- ◆ George Openshaw, NE ¼ (Lot 4),
- ◆ George A. Smith, Trustee for The Church of Jesus Christ of Latter-day Saints, NW ¼ (Lot 3),
- ◆ Robert Crookston SW ¼ (Lot 2),
- ◆ N.L. Christenson East ½ of SE ¼ (Lot 1),
- ◆ M. Pedersen West ½ of SE ¼ (Lot 1). (Morgan, Sr. and Ireland 1950 ca.)

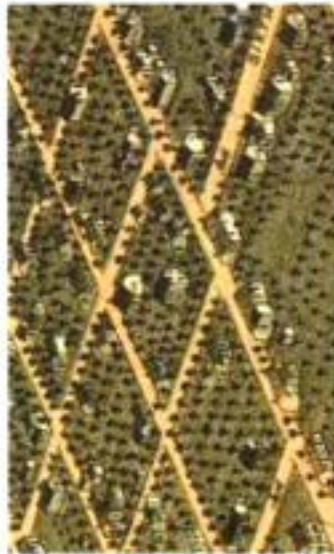
Figure 2-5. 1870 birds eye map view of Block 407 at center. Credit: Koch & Chicago Lithographing Co.

Street (H Street). G Street is known as Elm Street and the east-west street is Fruit Street (First Avenue). (Koch and Chicago Lithographing Co. 1870) It is unclear if any of these structures are had been replaced prior to the 1889 map. The 1875 birds eye view image of Salt Lake City provides only an oblique view of the Avenues neighborhood and South Temple Street. In this image, development in the area appears consistent with that visible in the 1870 image—most of the development was still south of 4th Avenue. The eight buildings on the block are in a similar arrangement as 1870 but with one additional building on Fruit Street (1st Avenue) between the houses on the corners, likely having most, if not all, of the lots having been developed.³ (Glover and Stronberg & Co. Lith. 1875)

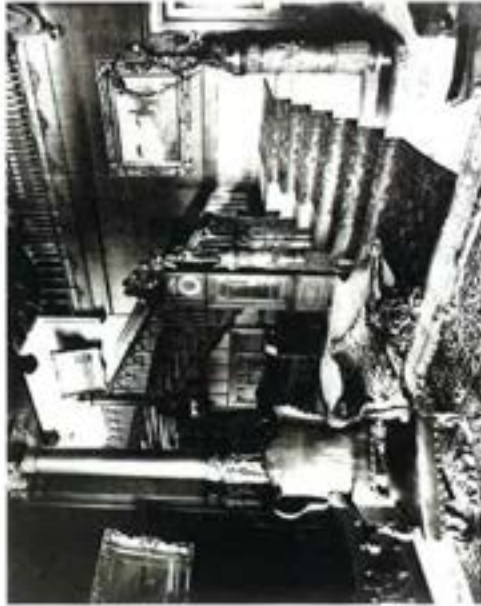
Figure 2-10. The Grand Hall served as the front entry and Grand Staircase of the Keams Mansion as it appeared in 1907. Credit: Utah State Historical Society

The floor of the Grand Hall is hand-chipped African and Roman (Italian) marble individually laid in mosaic pattern. The wainscoting, fireplace, cornice and columns are rare French Oak that is no longer harvestable. The oval glass in the ceiling was installed after the 1993 fire as a way to increase privacy and fire management. The front doors are built of wrought-iron and have removable leaded glass for cleaning. The fireplace's carved head is that of the mythological God of the Sea, Neptune. The deep green marble tile on the face of the mantel is "Italian Verde" marble. Scenes from the Renaissance paintings "The Rape of Sabine's" and Botticelli's "Graces" are carved into the two columns that support the archway leading to the second-floor stair and landing. Walls were finished originally in burlap with warm cherry red stenciling. The background was red with green scrolls. (Nielsen 2018a) At the center and top was a backlit illuminated dome.

Keams at the 1900 Paris Exposition. The material is pig metal which is 85% bronze and 15% zinc, which allowed greater flexibility for carving (see Figure 2-10). (Nielsen 2018a)

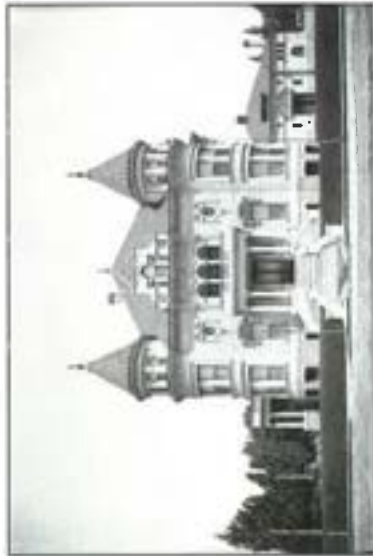
Figure 2-11. 1907 image of the Kearns Mansion and carriage house.
Credit: Utah State Historical Society.

The carriage house was built concurrently with the mansion (see Figure 2-11). The building is 1/2 stories in height with an exterior also of oolite limestone and similar Chateausque architectural details. The horse's head sculpture over the front bay doors provides a clear signal of the building's original use. The first floor was designed for elaborate horse stalls and area to hitch and unhitch buggies and a tack room. The stalls were constructed of two-inch planking, tongue and groove, and fine iron and brass grillwork around the top of the stalls. The second floor was split between three areas: grain and hay storage above the stalls, buggy storage, and a caretaker's apartment and bathroom. A hand-operated elevator in the southwest corner hoisted buggies up and down for storage and use. (Arrington & Swinton 1987, 14-15)

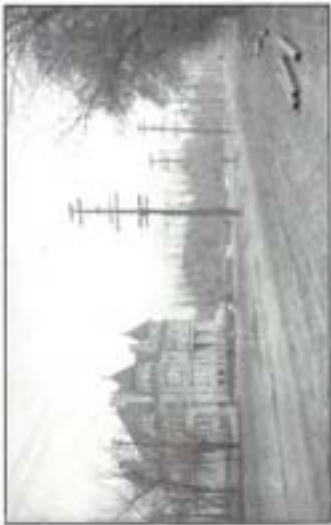
Figure 2-12. 1905 image of South Temple near the Kearns Mansion. Note the narrow park strip prior to street completion. Credit: Utah State Historical Society.

Broader changes on and around Block 407 took place during the Kearns Family Period that influence the overall setting of the block today. For example, South Temple was an unpaved road with a cornering streetcar line with an electrical catenary at the time the Kearns Mansion was constructed. The road was a two-level feature with the elevation of the north half as much as two feet higher than that of the south half in some areas (see Figure 2-12).

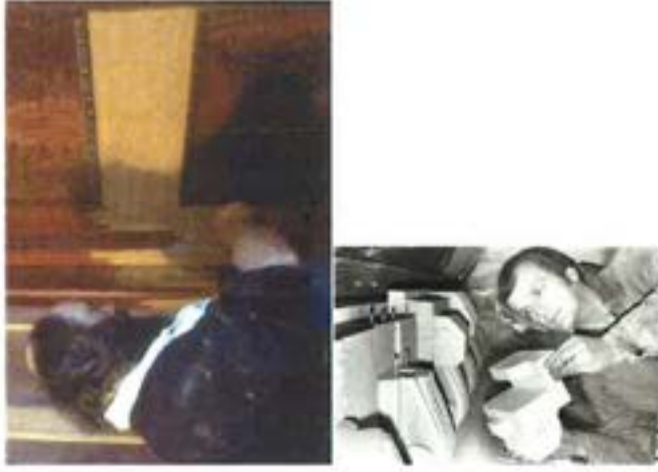
Figures 2-17 and 2-18. Skilled craftsmen from across the U.S. were employed in the Kearns Mansion restoration of the late 1970s. Credit: Arrington & Swinton.

On the exterior, Condria re-carved and replaced stones that had been completely eroded. He was able to obtain the oolite limestone from the same quarry in Sanpete County that the original stone came from, even though it was defunct at the time. It took over three years to complete the stone restoration. The interior required equal if not more attention as the exterior. (Viera 1980, 4) Surfaces, from mosaic tile to hardwood to African and Italian marble, had rarely if ever been cleaned and many high relief plaster motifs had been painted. Skilled craftsmen from all over the U.S. were brought to Utah to pay careful attention to every characteristic and detail of their specialized material (see Figures 2-17 and 2-18). (Parkinson 1980, 6)

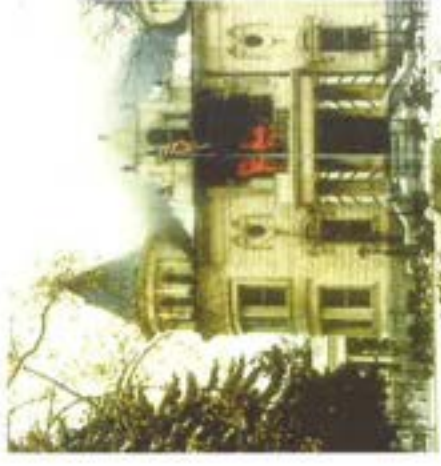
Figure 2-19. The 1993 Christmas fire at the Governor's Mansion led to the second major restoration project in the mid-1990s and improvements in the living quarters for the first family. Credit: The Salt Lake Tribune.

DFCM and other state agencies engaged in serious discussions after the fire concluding that enough of the Kearns Mansion's original materials remained to warrant restoration. The focus was to restore the building to its 1902 appearance and to keep as much of the historical interior materials as possible. Exceptions included the installation of a fire sprinkler system, new wiring and plumbing, new HVAC, a security system, and the building's first seismic upgrades. The family living quarters were redesigned to provide more security and privacy with fire exits added to the second and third floors. (Nielsen 2018a) It took nearly three years to restore the Kearns Mansion after the 1993 fire and cost about \$7.8 million.

All interior surfaces had to be removed in order to clean soot and repair smoke damage. The plaster in the Informal Dining Room had to be cleaned in place since it was determined that it could not be replicated. All the interior walls were removed and rebuilt using the same lath and plaster techniques originally employed. Original Victorian-era colors were returned to the walls. Most of the stencils were damaged and had to be reproduced from historic photos. Glazes were used to brighten painted surfaces like the ballroom ceiling and to emphasize sculptural details in three-dimensional elements like the dome. (Nielsen 2018a)

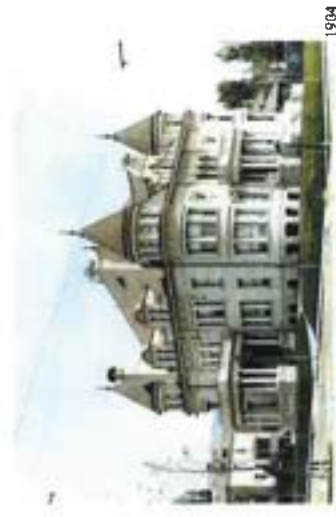
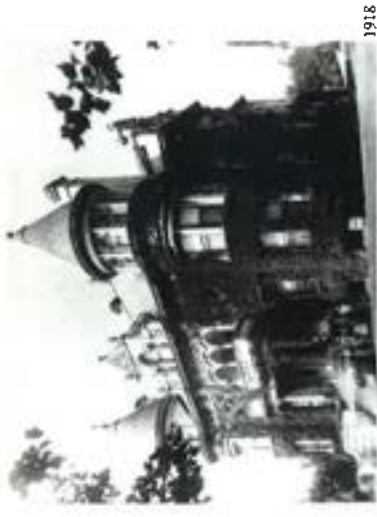
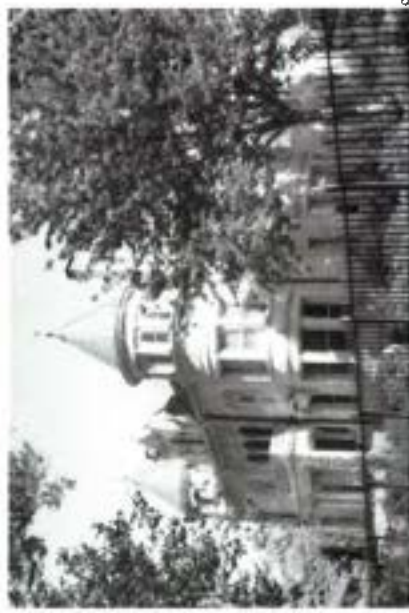
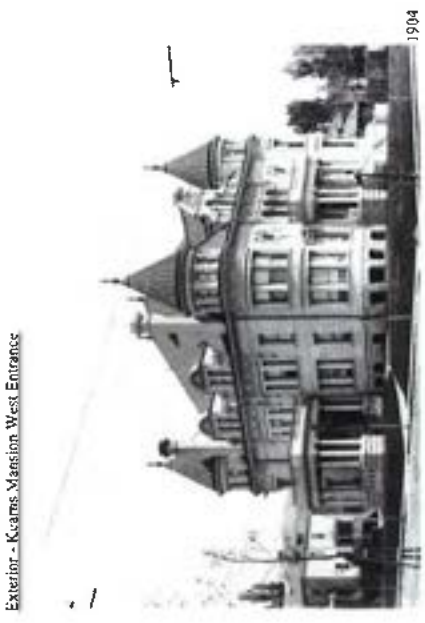
Exterior - Keams Mansion Roof

The following Keams Mansion photographs show two major exterior alterations and one major interior alteration over time. While other interior modifications to the original floor plan have been made, they were either in private spaces (Second floor and Basement) or of more minor nature.

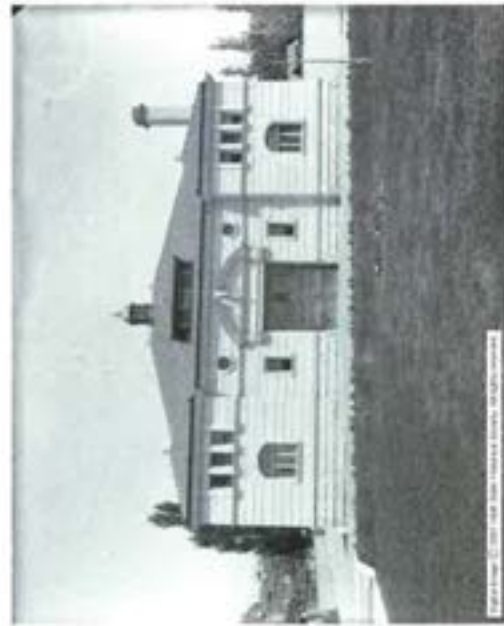
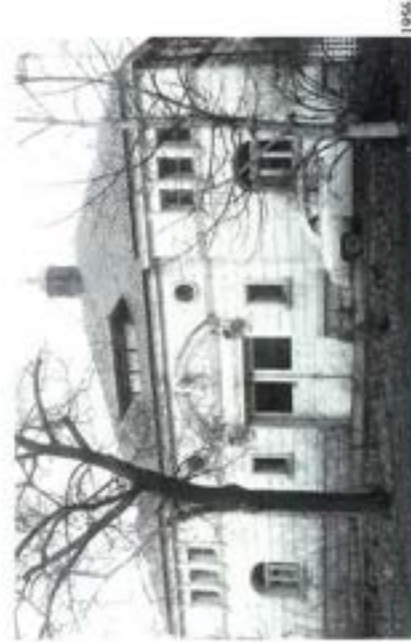
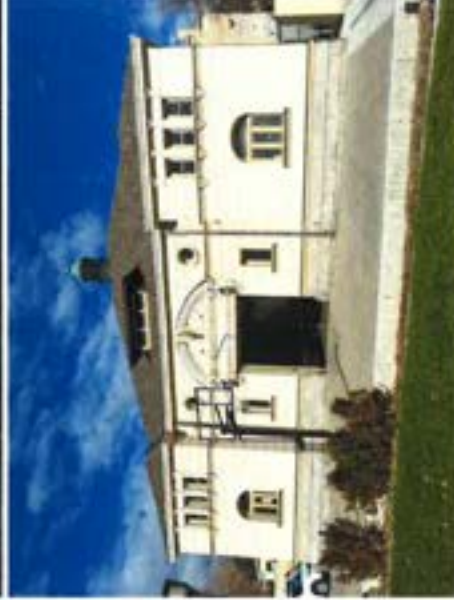
Exterior - Main Facade

The Keams Mansion Carriage House photographs show that the exterior has been consistently maintained in nearly original condition since its construction in 1902. A major exterior restoration and seismic retrofit was completed in 2010. The interior floor plan, while still reflective of the original openness on both floors, has been altered in order to facilitate a security suite, secure communications equipment, and a restroom. Therefore, there is not a large degree of visual change seen in the following comparative photos.

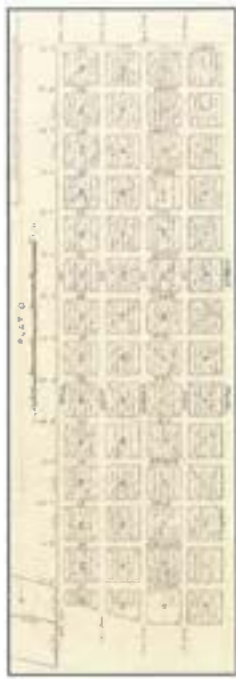
Figure 3-2. The original 56 blocks of Plat D. Credit: Nicholas G. Morgan, Sr.

By 1857, the survey Plat D was completed and filed by city and territorial surveyor Jesse Fox (see Figure 3-2). It encompassed 56 blocks in the northeast quadrant of the city on the north slope known as the "dry bench." Much of this area was within the large estate of Brigham Young. The layout of Plat D marked the first deviation from the Plat of the City of Zion but was still laid out on a strict north-south/east-west grid. Blocks of Plat D were surveyed to be 20 rods square (2½ acres) with streets at five rods wide (82½ feet) and sidewalks at 10 feet wide. These all deviated from the Plat of the City of Zion standard of 40 rods square (10-acre blocks), eight rods (132 feet) wide streets, and 20-foot-wide sidewalks and took an act of the Territorial Legislature to clear the plat from violating state law for land surveys. The atypical configuration of Plat D was likely an adaptation to the relatively steep terrain and lack of easily available freshwater in the area. The lack of water in particular would have made subsistence gardening on these lands more than challenging and less productive. Thus, the decision to plat smaller lots while still maintaining square blocks may have been based on the expected lack of productivity from lands in the area. (Haglund and Noisani 1980, 3).

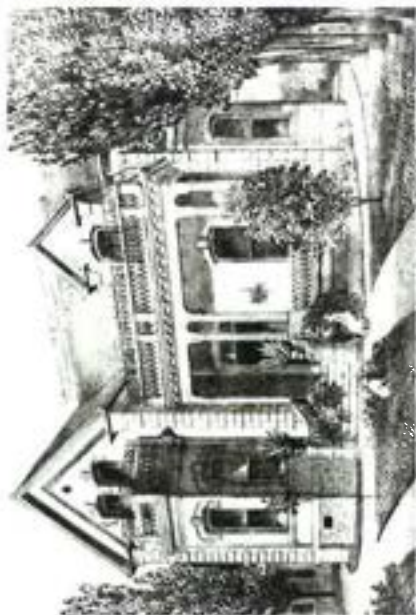
Figure 3-6. The Epley/Glendinning Residence as sketched by S.W. Danks in 1887.

The building was originally of Victorian Eclectic design with a sandstone foundation and base, structural brick walls, and stone quoins. Two second-story walk-out porches graced the main facade while two chimneys served the internal fireplaces. The gentry-arched windows display simple lintels with keystones marked with a reticel star on each. The main room on the first floor was a library while the northwest corner was the original kitchen and the northeast corner was the location of the original dining room. (Utah State Historic Preservation Office 1 2021)

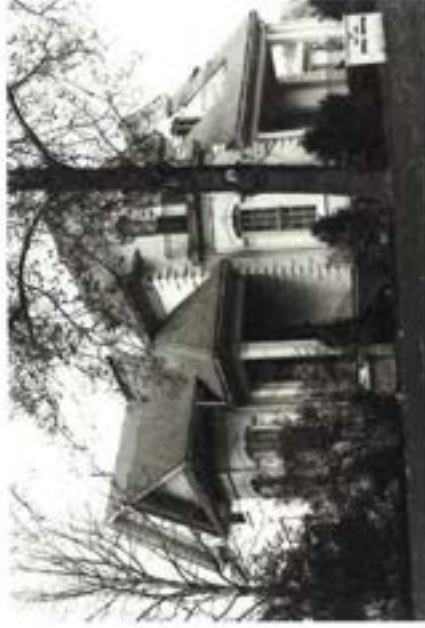
Figure 3-10. The Salt Lake Dental Hospital following many of the alterations, circa 1966. Credit: Utah State Historical Society.

By 1966, a one-story east addition and a two-story north addition were constructed as the dental hospital wing and patient rooms respectively. In order to accommodate the changes in the house, the roofline was heavily altered and the primary entrance was moved from the central doorway to the southwest doorway and porch. While the ground floor was wholly used for the dental practice, the upstairs had been divided into a series of small apartments (Utah State Historic Preservation Office | 2021)

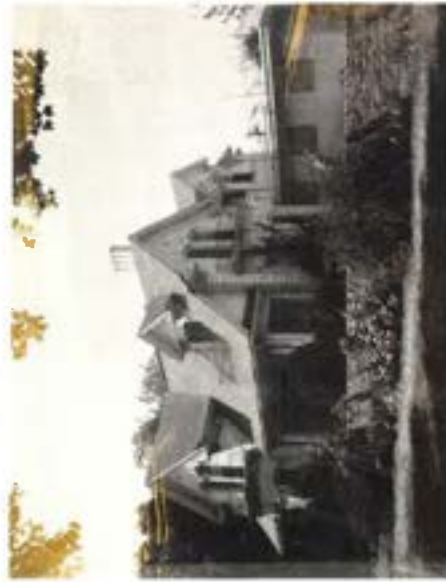
Figure 3-11. The 1966 additions can be clearly seen from this view looking northeast.
Credit: Salt Lake County Archives.

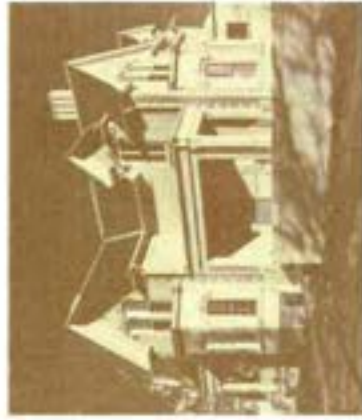
Figure 3-13. View of the Glendinning House after the late 1970s rehabilitation for the Utah Arts Council headquarters that reversed the faux mansard roof among other positive alterations. Credit: Utah Heritage Foundation

Exterior restoration removed the two-story addition on the north, reversed the faux Mansard roofline that obliterated the upper porches, and moved the main facade entrance back to the center doorway from the southwest corner (see Figure 3-13). (Utah State Historic Preservation Office 1 2021) Completely new heating, cooling, mechanical, and wiring systems were installed. Interior choices were to paint moldings white and walls dark, sand and refinished the original wood floors that remained and the main stairway, and cleaned and repaired all fireplaces.

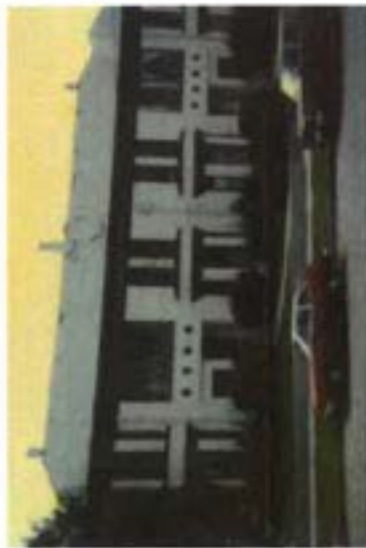
Figure 4-12. Kearns Terrace No. 2 as it appeared in 1983. Credit: Utah State Historical Society.

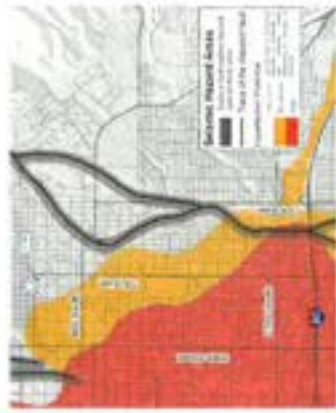
Figure 2 – Surface Fault Rupture Special Study Areas andliquefaction Potential.

The building site is near the Wasatch Fault in a region of a high seismicity (see Figure 2). According to seismicity, the chance of a magnitude 7.0 or greater earthquake occurring on the Wasatch Fault in the next 100 years is in the 25th percentile. The objective of this ASCE 41.1 retrofit evaluation is to identify potential building deficiencies in terms of seismic performance.

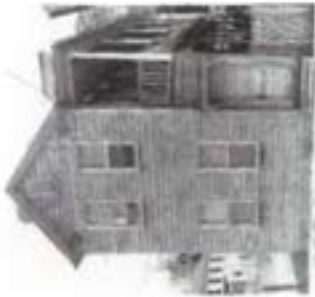
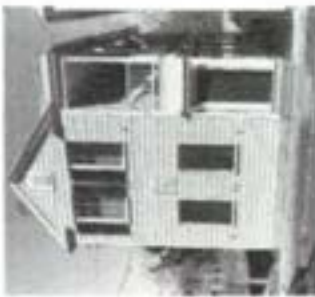
Maintaining condition of historic materials and features is the primary goal of Preservation as demonstrated here in this "before" and "after" photographs. Aside from minor repair and limited replacement of deteriorated materials, work on this house occurred primarily of repairing the wood masonry. Photo: Historic Charleston Foundation.

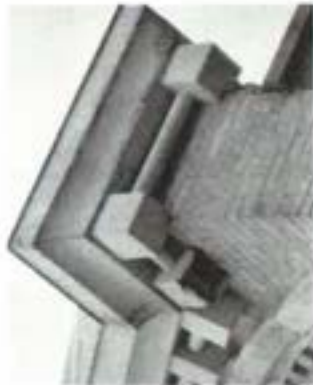
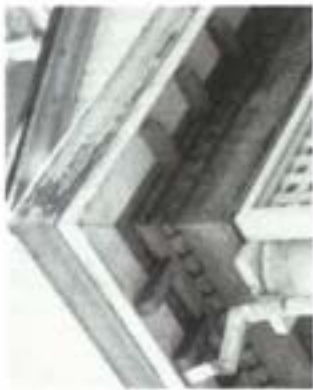
Two examples of "limited replacement in kind" show an appropriate scope of work within the treatment. Preservation. (a) One metal installation that has sustained damage from a faulty gasket will need to be replaced, and (b), neglected repairs to deteriorated wood cornice element (fauxon board and wood lions) mean that most of the historic materials were retained in the work.

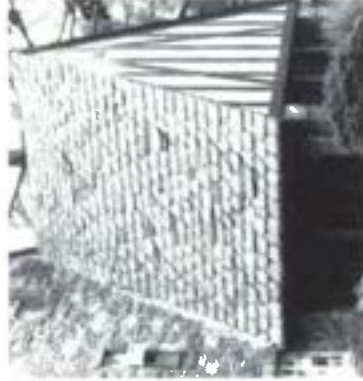
It is generally important to preserve materials that contribute to a building's historic character, such as the highly visible slate roof. In the event that repair and limited replacement are necessary, all new slate would need to match the old exactly. Photo: Jeffrey S. Lovine.

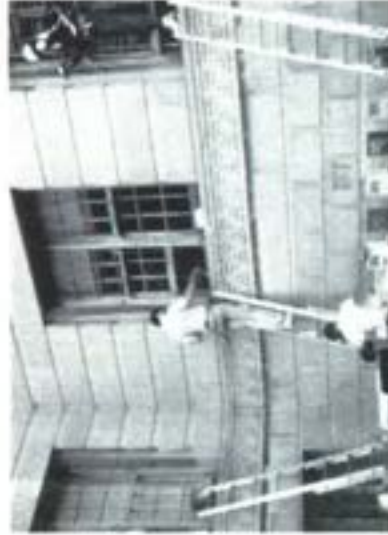
Preserving a building's historic windows generally involves cleaning, sanding, and repainting. While some repair work will most likely be undertaken within the scope of work on the institutional building, replacement of the window units will usually not be an appropriate preservation treatment. Photo: Chuck Fisher.

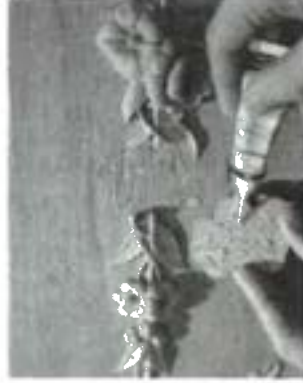
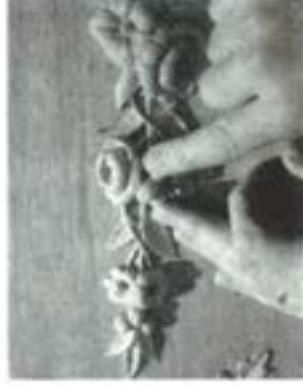
In Preservation, an appropriate level of intervention is established prior to work in order to maximize retention of historic materials. (A) A conservator is applying adhesive to 19th century composition ornament that has delaminated from its wood substrate. (B) The composite fragment is carefully held in place until the quick-setting adhesive takes hold. Photos: Jonathan Thomson.

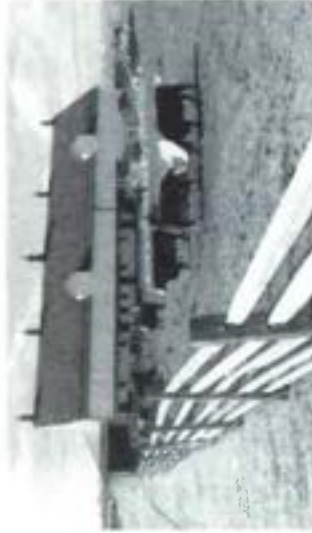
*The goal of preservation is to retain the historic form, materials, and features of the building and its site as they have changed – or evolved – over time. The Bank Barn was built in the 1820s, then enlarged in 1890 and again in 1914. Today, it continues to rule as a working farm structure as a result of creative preservation work. This included foundation regrading, a new gutter system, structural strengthening, and replacement of a severely deteriorated metal roof.
Photo: Jack F. Boucher, HABIS*

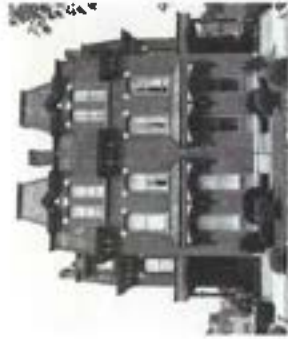
Original look of single-family row houses located between these houses were rehabilitated for a new use as retail operations, which are significant historic features and spaces and it is necessary to retain their historic appearance as much as possible.

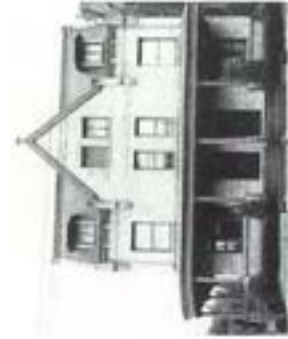
These houses were rehabilitated for a new use as retail operations, which are significant historic features and spaces and it is necessary to retain their historic appearance as much as possible.

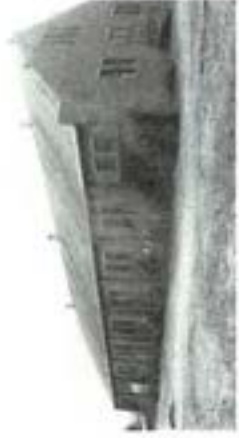
(a) An armory complex was rehabilitated for rental housing. (b) This view of the rear elevation shows the paired, nine-over-nine wood shingle windows and high hills that characterized the building. (c) After extensive rehabilitation work, the same rear elevation is shown with new skylight added to the roof, prefabricated panels filling the former brick areas, and new wood decks and privacy fences. Because the work changed the historic character, the project did not meet the Standards.

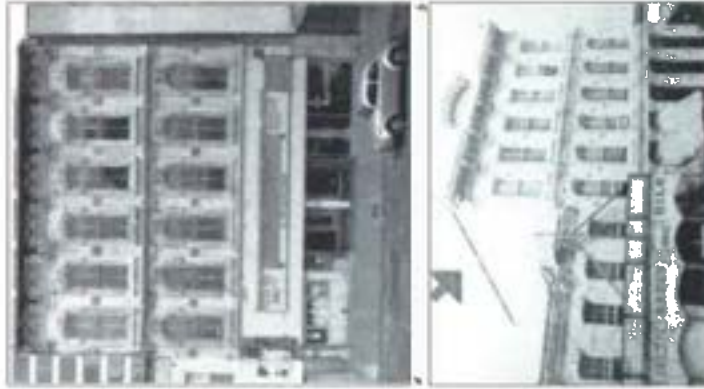
In the meantime, Rehabilitation, one opinion for replacing missing historic features is to use historical documentation and/or physical evidence to recreate the historic feature. (a) In this example, the ornamental cornice of an 1850s limestone building was missing, and the ground level storefront had been encroached upon. (b) Based on the availability of photographic and other documentation, the owners were able to accurately measure the cornice and its form to their historic condition. A historic material, fiberglass, was used to fabricate the missing pressed metal cornice, an acceptable alternative in this project. All work met the Standards.

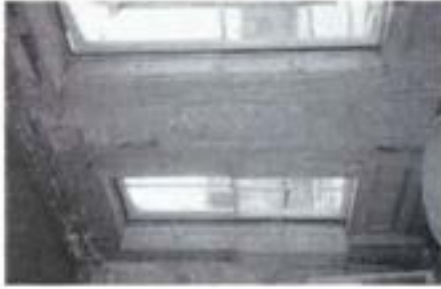
Rehabilitating historic buildings with styles such as 19th-century French Second Empire. Whenever lead-based paint begins to peel, chip, crack, or otherwise come loose (a), it should be removed in a manner that preserves the surface as well as the surrounding environment. In this example (b), the deteriorating lead-paint was removed throughout the apartment building and a compatible primer and finish paint applied.

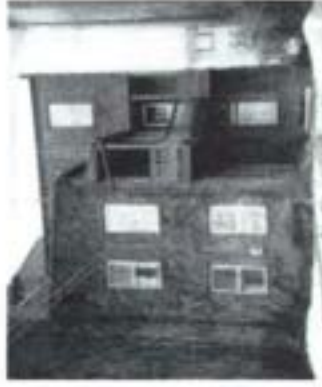
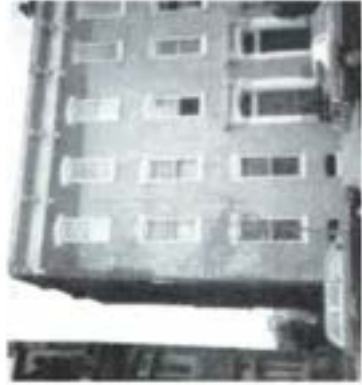
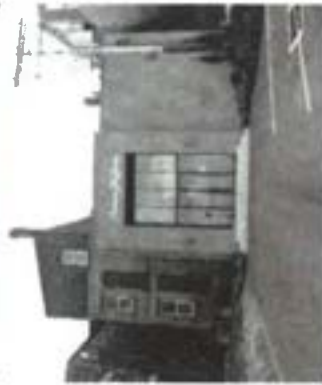
If a new elevation of a historic building is distinctive and highly visible in the neighborhood, allowing it may not meet the remaining (cultural) The Trinity brick rowhouse featured a second-story gallery and brick kitchen wing, characteristic of other residences in the district which backed onto a connecting roadway. (7) In the rehabilitation, the wing and gallery were demolished and a large addition constructed that severely impacted the building's historic form and character.

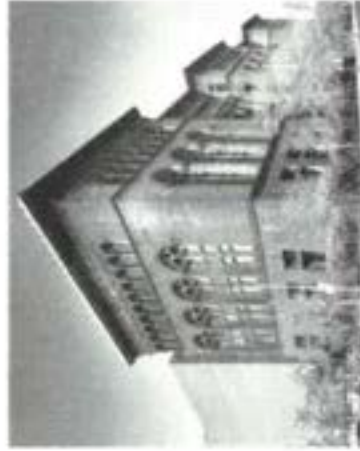
Rehabilitation, like Preservation, acknowledges a building's change over time; the retention and repair of existing historic materials and features is thus always recommended. However, unlike Preservation, the chief goal of Rehabilitation is to—respectfully—add to or alter a building in order to meet new use requirements. This downtown Chicago library was expanded in 1981 when additional space was required with light and humidity control for the rare book collection. The compatible 10-story wing was linked to the historic block on side and rear elevations. Its simple design is compatible with the historic form, features, and detailing; old and new are clearly differentiated. Photo: Dave Clifton.

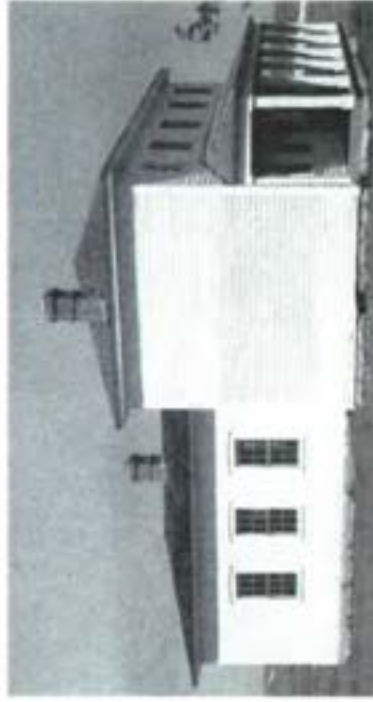
In a project at Fort Hays, Kansas, the wood frame officers' quarters were restored to the late 1860s—their period of significance. This included replacing a missing kitchen ell, chimney, porch columns, and cornice, and closing a later window opening in the main block. The building and others in the museum complex are used to interpret frontier history.

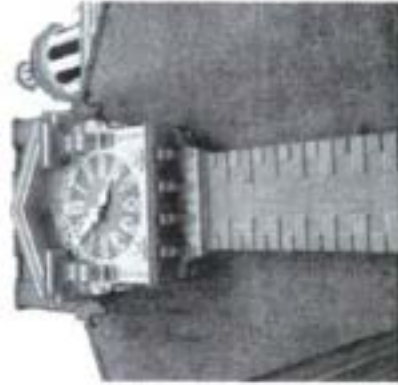
The Standards for Restoration call for the repair of existing features from the restoration period as well as the recreation of missing features from the period. In some instances, when missing features are replaced, historic materials may be considered if they carry the appearance of the historic materials. In this case, for a Philadelphia Independence Hall, the clock was re-built in 1972-73 using cast iron and wood with fiberglass and polyester bronze ornamentation. Photo: Lee H. Niden, FMA

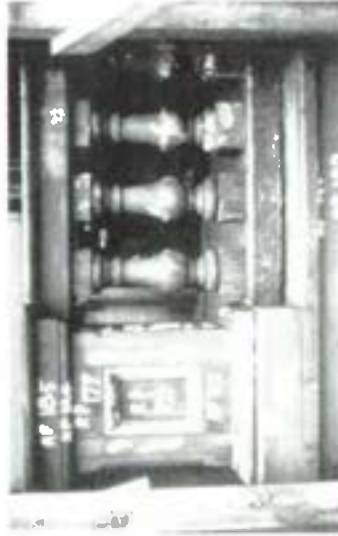
Portals of the small porch on an Italianate mansion were carefully numbered prior to Restoration. Some original elements were removed in place, while others had to be removed for repair, then reinstalled. Any elements too deteriorated to save was replaced with a new one replicated to match the original design. Photo: Morgan W. Phillips

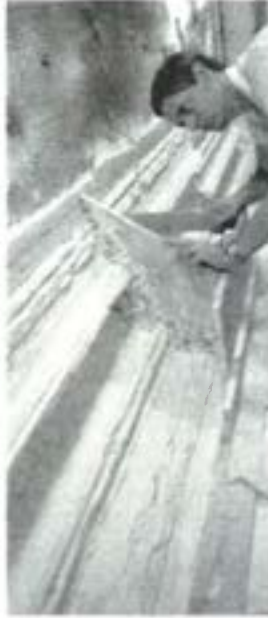
The missing plaster mantle has served as part of an archival project to restore a residence to its original appearance. The traditional method of producing a cornice is unchanged today.
Photo: Old-House Journal

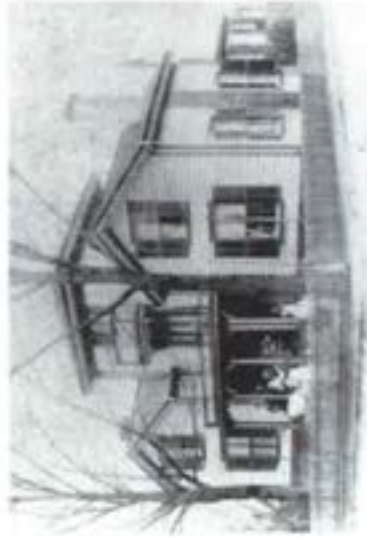
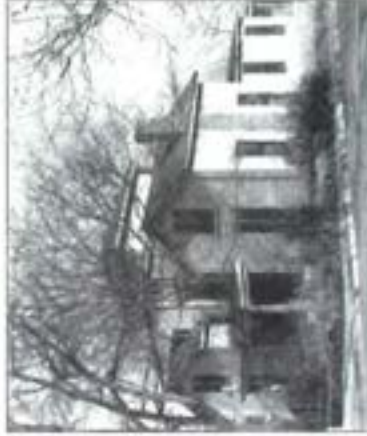
This ca. 1900 photograph (left) would be invaluable to guide restoration of the deteriorated house (right) to its documented earlier appearance, complete with decorative trim, shutters, polychromed exterior, and fencing. Photos: Center, North Carolina Department of Archives and History

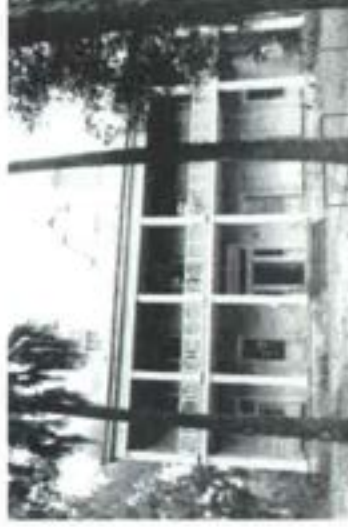
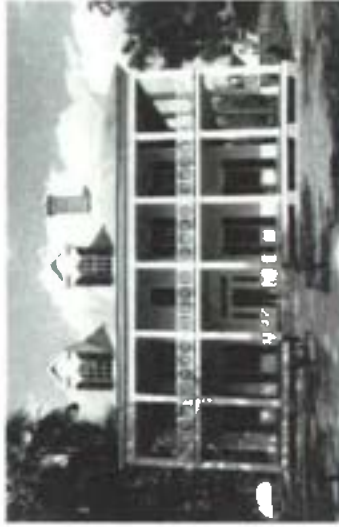
The Brown-Mulholland House in Tallahassee, Florida, in 1895, is shown (a) before and (b) after the restoration. Over the years the east (far right) side of the veranda had been jilted in a acid-bay. During the restoration, the floor joist was removed and the east veranda, together with its flooring, stairs, and foundation, restored. Photo: City of Tallahassee, Community Development Department.

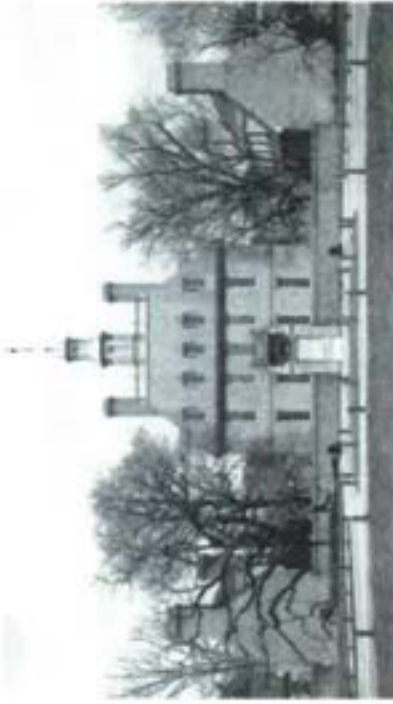
In the 1930s reconstruction of the 18th century Governor's Palace at Colonial Williamsburg, Virginia, the archaeological remains of the brick foundation were carefully preserved in situ, and serve as a base for the reconstructed walls. Photo: The Colonial Williamsburg Foundation.

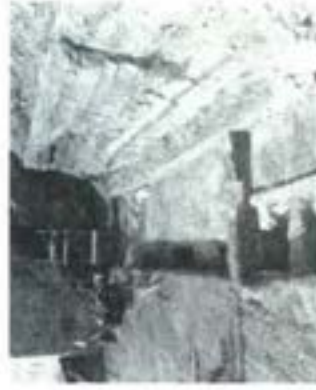
Reconstruction should generally be based on an extensive archaeological investigation, as was done here to recreate a non-curving chimney building at Fort Snelling.

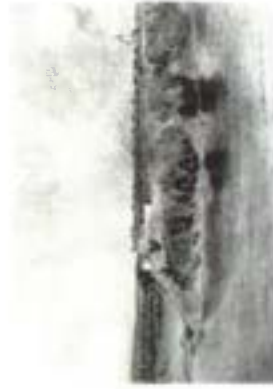
Jean Baptiste Weniger's watercolor rendering of Fort Snelling, Minnesota, in 1857, is aesthetically pleasing, but the overall view does not contain adequate documentary evidence for a Reconstruction. Oral histories are also unavailable sources of documentation for treatment.

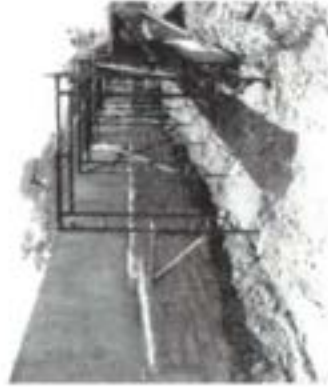
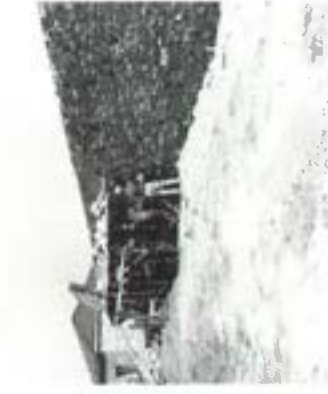
(a) and (b). Two photos illustrate the use of contemporary construction materials and techniques within the treatment. Reconstruction. Because Reconstruction is employed to portray a significant earlier time, usually for interpretive purposes, substitute materials may be appropriate if they are able to convey the historic appearance.
