BLOCK 407 MASTER PLAN

PROJECT NAME: BLOCK 407 MASTER PLAN
GSBS PROJECT NUMBER: 2-27-2022-04
DATE: September 9, 2022

COMMUNITY DEVELOPMENT
SALTLAKE COUNTY
PUBLIC SERVICES

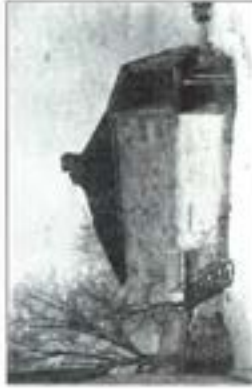
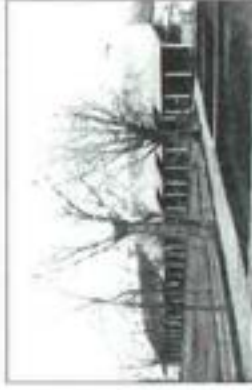
(a) and (b). This view of the Officers Quarters at Fort Snelling (ca. 1865 to 1900) not only provide information on the materials and form of the historic block, they document the wooden walkways and other landscape features such as stairs, railings, and tree placement. Historical and pictorial evidence would need to be combined with specific physical evidence in order to make the case for Reconstruction as a treatment.

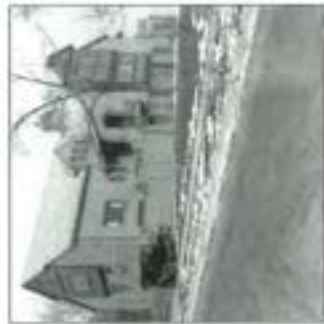
Tudor Revival

- steeply pitched roof
- cross-gabled roof lines
- decorative half-timbering
- decorative masonry
- arched doorways
- casement windows, often with leaded, diamond panes
- projecting entryway that follows slope of front gable
- canted edges on roofing (an attempt to imitate thatch)
- use of stucco or brick

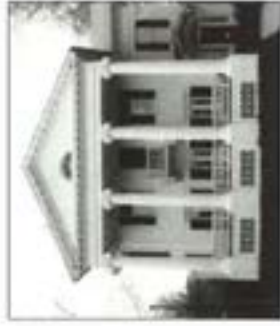
Neoclassical

- full-height porch with a pediment; round columns with complex capitals. In some instances the porches are curved porticoes
- hipped roofs
- eaves with dentils, modillions, prominent frieze
- shutters
- paneled doors surrounded by pilasters and a pediment
- double-hung windows; usually one-over-one, but sometimes six-over-six or six-over-one
- low porch rails with turned balusters

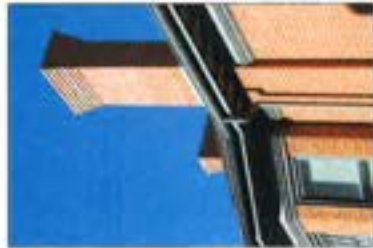
Variations in the brick texture and the pointing profile are used in this case to define the wall, the window bay and the chimneys.

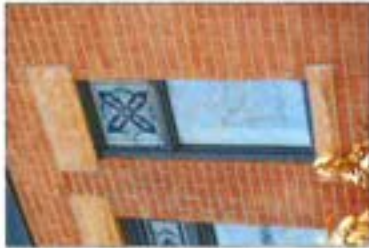
Matching the existing brick pattern to build and the composition of the mortar help to ensure the integrity of the brick and sashwork and consequently its architectural character.

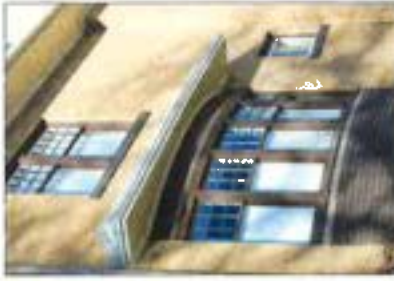
Great care is required to ensure that if cleaning is really required this is achieved using the gentlest means possible, and not using abrasive methods. In contrast to the care taken above, the brick surface below has been completely destroyed using abrasive cleaning methods.

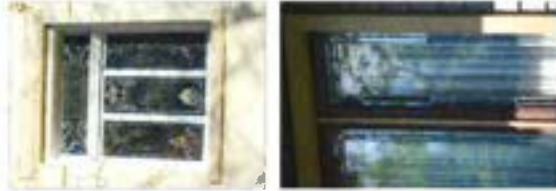
Decorative windows, such as those in the adjacent photos, are a key character-defining element of the building. Typically, windows on the front of the building, and on sides designed to be visible from the street, are key character-defining elements. A window in an obscure location, or on the rear of a structure, may not be. Greater flexibility in the treatment or replacement of such secondary windows may be appropriate.

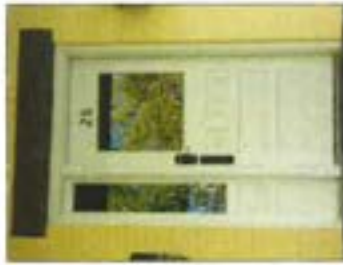
The paneling on this door is solved in the adjacent side-light panel, and together with the doorway itself create a cohesive design composition.

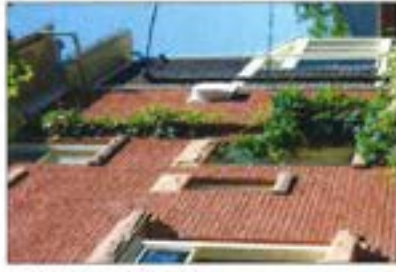
A new addition which is subordinate to the house and differentiated by height, materials, features/texture and window profiles and details.

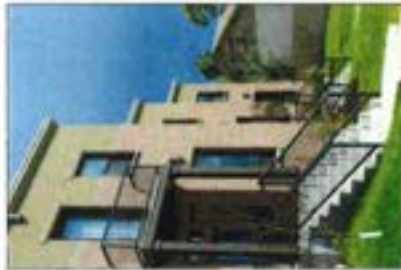
A strong vertical emphasis is created by the facade modules, tall entrance porchway, and the composition and proportions of windows and windows.

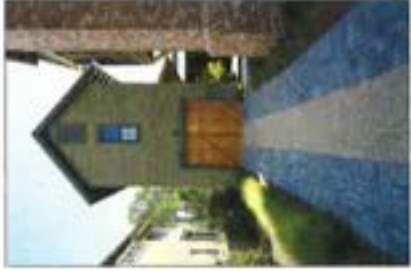
Although higher than would normally be appropriate in Salt Lake City historic residential neighborhoods, the same openness in this well-detailed building effectively create a central focal point for this building.

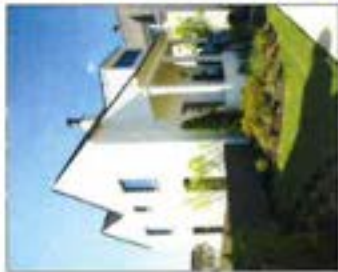
Window reveals and contemporary detailing to the porch and front door window add both a visual strength and modern scale interest.

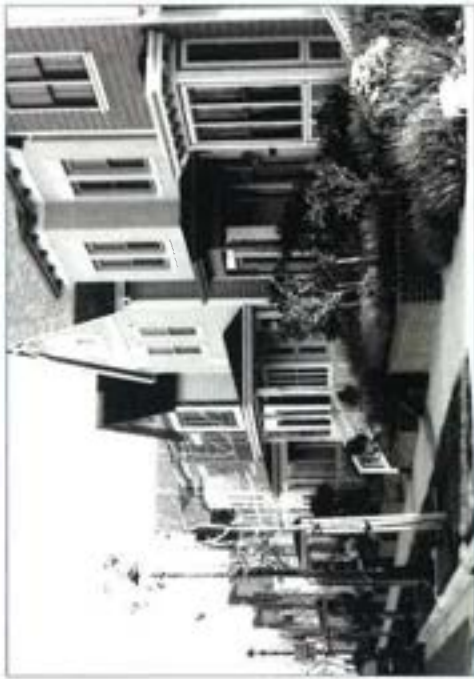
Street Facade Evaluation

This is an illustration of the application of the Design Guidelines for New Construction for a Street Facade.

The design guidelines for New Construction are summarized above under the principal topic headings, with the members of the pertinent design guidelines of the former page evaluated the role and performance of the design guidelines in the composition of the street facade, with the number reference relating to the design guideline topic above.

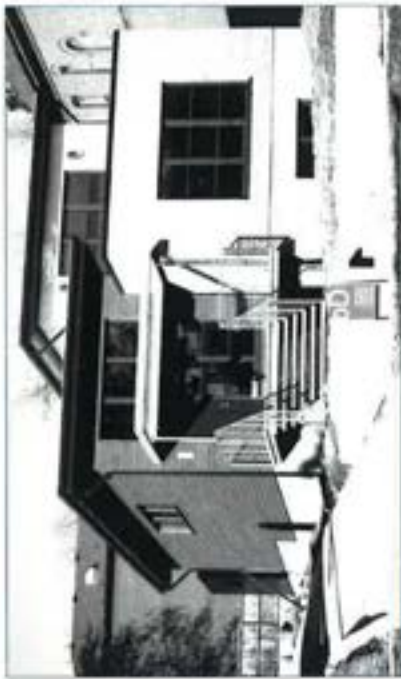
Building Evaluation

This is an illustration of the application of the Design Guidelines for New Construction for an individual Building in context.

The design guidelines for New Construction are summarized above under the principal topic headings, with the numbers of the pertinent design guidelines.

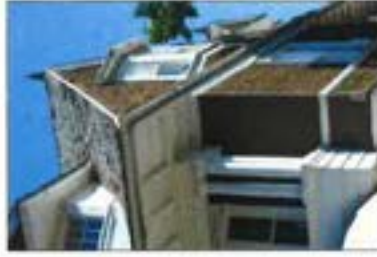
Wood shingles help to unify porch walls and roofscape, creating visual texture as a background to Classical detail.
